ENSLEY

Historic Building Survey

And National Register Nomination - 2008

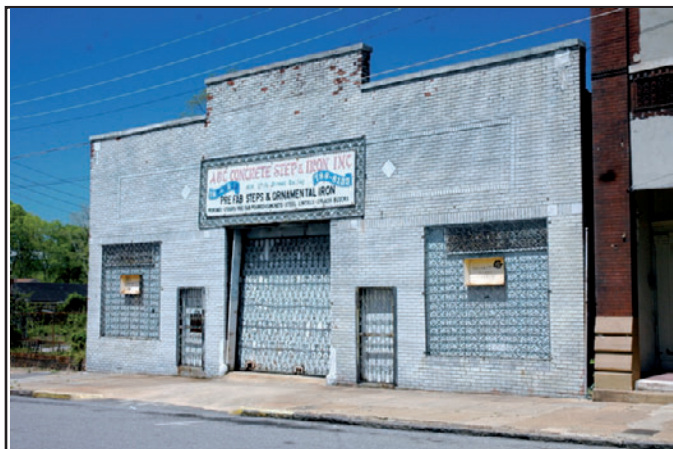
Construction and design details indicate that this building was constructed circa 1925; the building is not shown on the 1911 Sanborn map but is shown on the 1928 edition as a garage with a capacity of 50 cars, a concrete floor, and of "slagtex" construction; it is shown on the 1951 Sanborn map as sash balance manufacturing facility with steel trusses

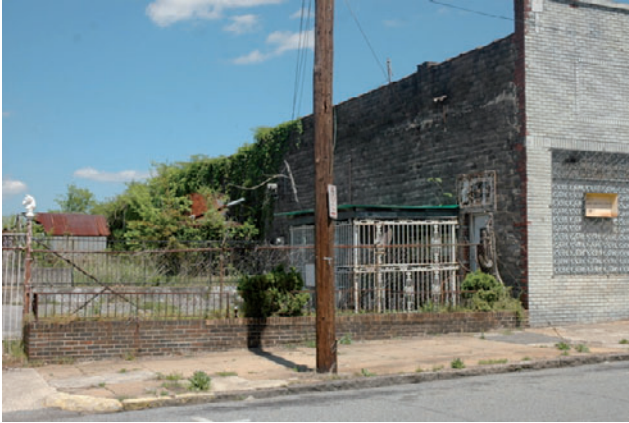
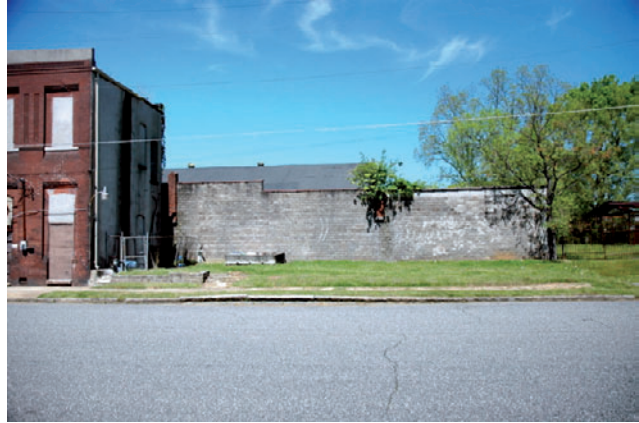
Location: **17th St. Ensley 418**

infilling of windows and doors and the replacement of the front door

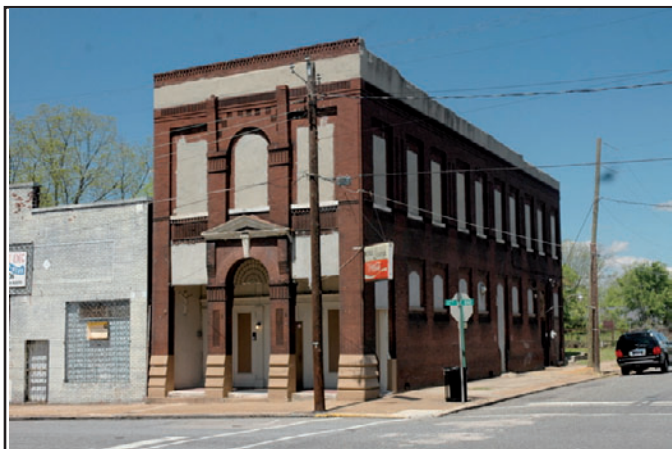
Local tradition holds that this building was constructed circa 1890 as a saloon. The 1902 Sanborn map indicates that the first floor was in use by a store by that time. Although it has lost its original windows, the elaborate brickwork of this late Victorian style building is particularly notable.

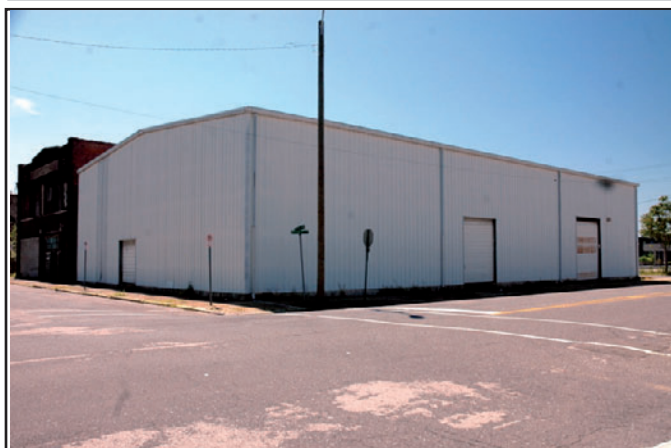
Photo Roll Neg. View of:
D003A _____ Facade, fac. S

Construction and design details indicate that this building was constructed circa 2000.

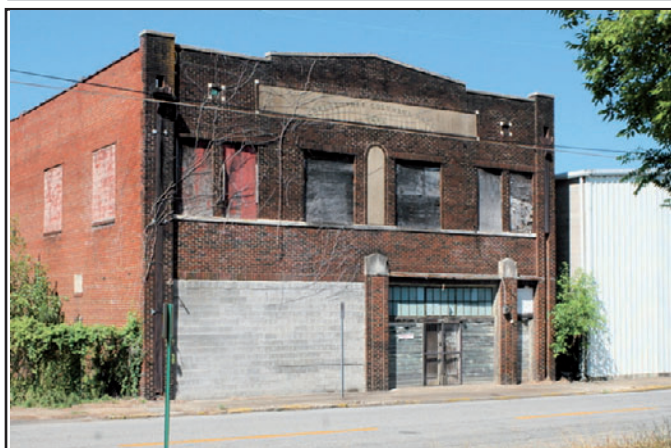
Photo Roll	Neg.	View of:
D004A	-C	Oblique, fac. W
D004D	-S	Details
D001

According to a cast sign panel at the parapet, this building was built in 1925 as the Christopher Columbus Hall; a metal clad 1-story "transfer" building is shown at this location on the 1911 Sanborn Map; this building is shown on the 1928 edition with a store at the 1st floor and a Hall at the 2nd; the map shows the building as a club: Chrsitopher Columbus Halls were typically established as social organizations by the Italian-American community.

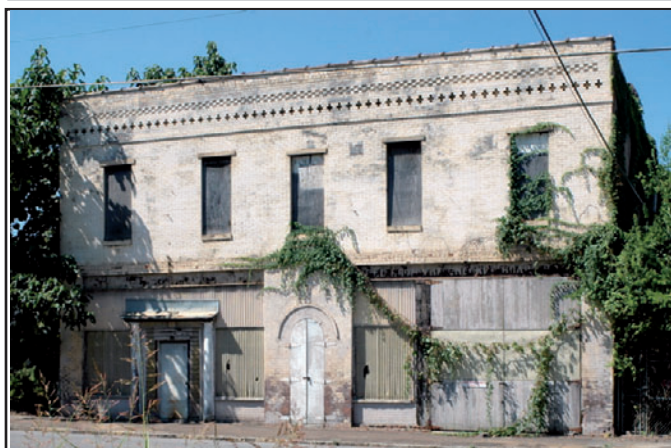
Photo Roll	Neg.	View of:
D005A		Facade, fac. W
D005B		Oblique, fac. SW
005C		Oblique, fac. S
005D	-J	Additional views

Construction and design details indicate that this building was constructed circa 1905. A 1-story store building is shown at this location on the 1902 Sanborn Map and this building is shown on the 1911 edition as a 2-unit commercial building with a warehouse to the west and a store to the east. The 1928 edition shows the building as a wholesale grocery operation and the 1951 map shows it as "one store" with a club on the 2nd floor.

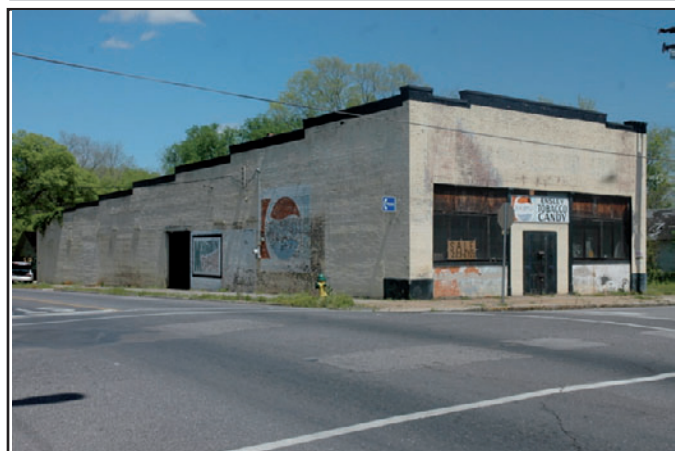
Construction and design details indicate that this building was constructed circa 1925; a house is shown at this site on the 1911 Sanborn map; this building is shown on the on the 1928 and 1951 editions as a store.

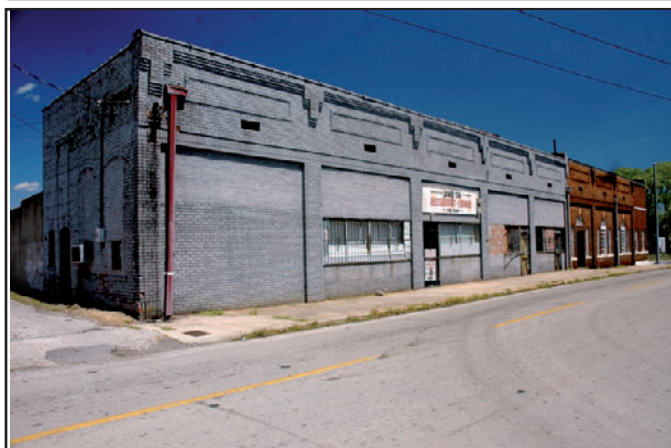
Photo Roll Neg. View of:
D007A Oblique, fac. N

Construction and design details indicate that this building was constructed circa 1925; a different store is shown at this site on the 1911 Sanborn map; this building is shown on the on the 1928 with a store to the west and a photo shop to the east; the 1951 edition records a restaurant to the west and a store to the east; the building is architecturally similar to the adjacent building at 1724 Avenue E suggesting that the two were built at or near the same time.

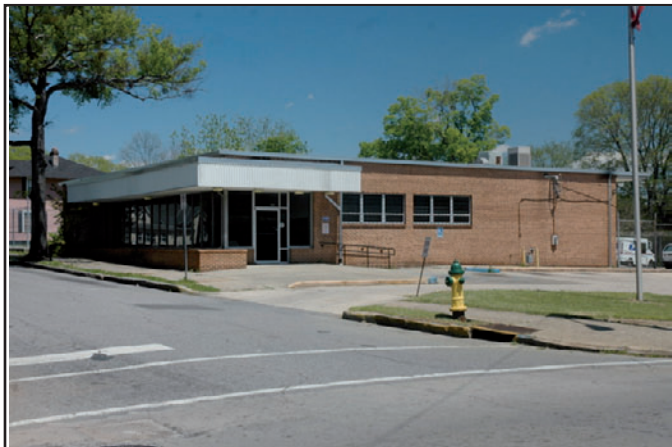
Photo Roll Neg. View of:
D008A Oblique, fac. N

Construction and design details indicate that this building was constructed circa 1960 and documentary evidence indicates that it was constructed circa 1964; the building was built as a U.S. Post Office; two houses are shown at this site on the 1951 Sanborn map. According to Landmarks of Ensley: "The first post office in Ensley was located on Avenue E, between 19th and 20th streets." The subsequent post office was built circa 1910 and "was torn down in 1964 when the present one was built on 18th Street and Avenue G."

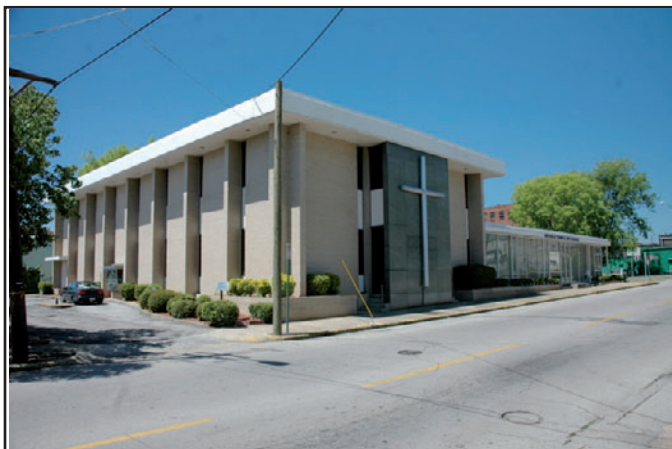
Construction and design details are consistent with the tax assessor's date of 1973; a house is shown on this site on the 1951 Sanborn map.

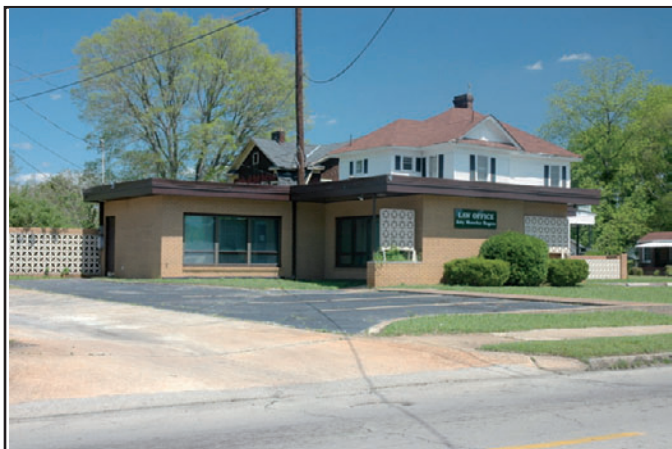
Construction and design details indicate that this building was constructed circa 1975; the site was vacant on the 1951 Sanborn map and the 1928 edition shows a house on the site.

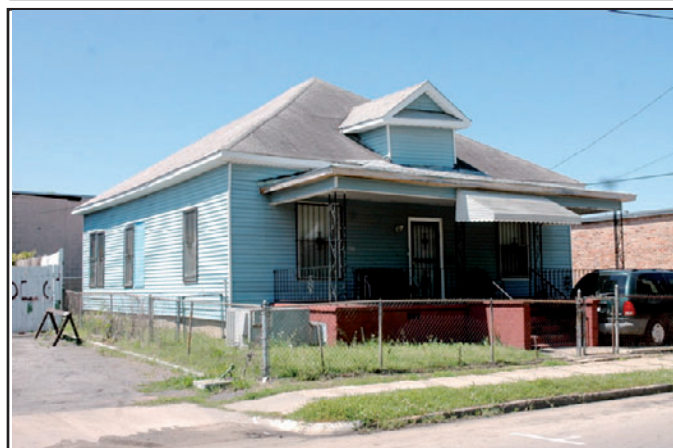
Photo Roll Neg. View of:
D011A Oblique, fac. W

Rectangular 1-story frame pyramidal form dwelling with a hipped composition shingle roof with a central decorative pedimented gable dormer; faces NE, rectangular 3x3 bay core; less than full façade hipped porch with replacement metal supports; central entrance at façade flanked by single 1/1 windows, similar single and double windows at side elevations; replacement synthetic siding (1980 ca.)

replacement synthetic siding

While construction and design details indicate that this house was constructed in the early 1900s, documentary evidence indicates that it was built circa 1930; the house is shown on the 1951 Sanborn map, but a the site is shown as the rear yard of a house facing Avenue I on both the 1911 and 1928 editions.

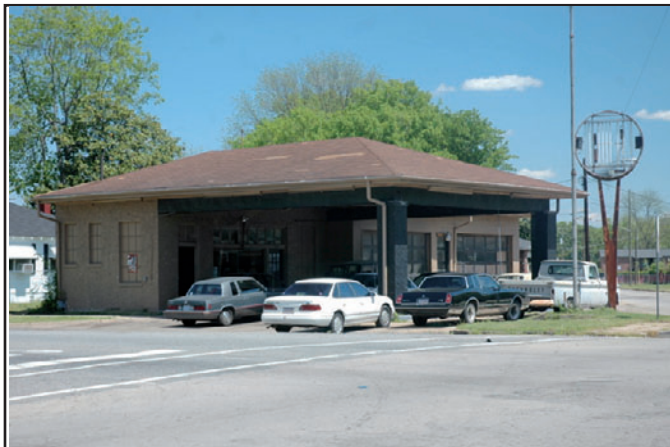
Photo Roll	Neg.	View of:
D012A		Oblique, fac. E
D012B		Facade, fac. NE
D012C		Facade, fac. NE

Construction and design details indicate that this building was constructed circa 1925; the building is shown on the 1928 Sanborn map

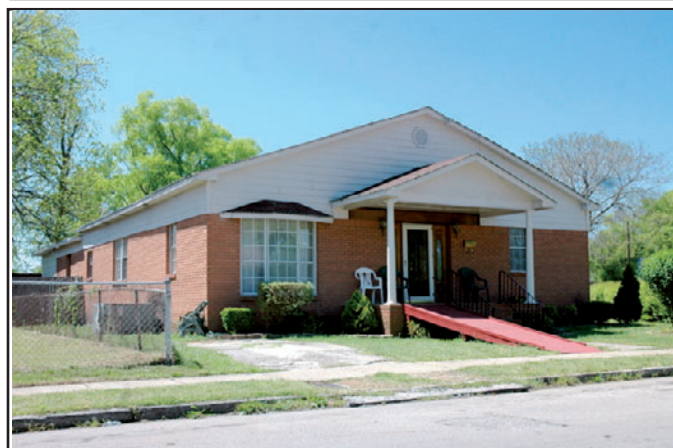
Photo Roll Neg. View of:
D013A _____ Oblique, fac. W

Construction and design details indicate that this house was constructed or represents a complete remodeling of an earlier house circa 1985.

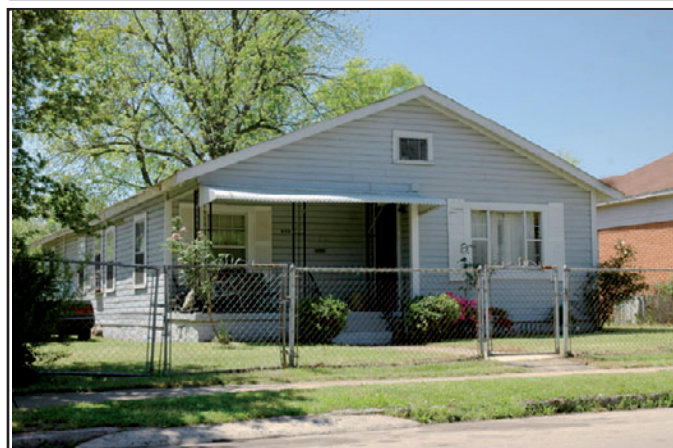
Photo Roll Neg. View of:
D014A _____ Oblique, fac. W

Rectangular 1-story frame gable front form dwelling with a front gable composition shingle roof; faces NE, rectangular 2x5 bay core with rear gable extension; less than full façade recessed porch with replacement decorative metal supports; entrance at east elevation within porch, tripartite picture window at west bay of façade, single 6/6 window at east bay of façade, similar windows at side elevations; replacement synthetic siding (1985 ca).

Construction and design details indicate that this house was constructed circa 1945 and was remodeled circa 1985.

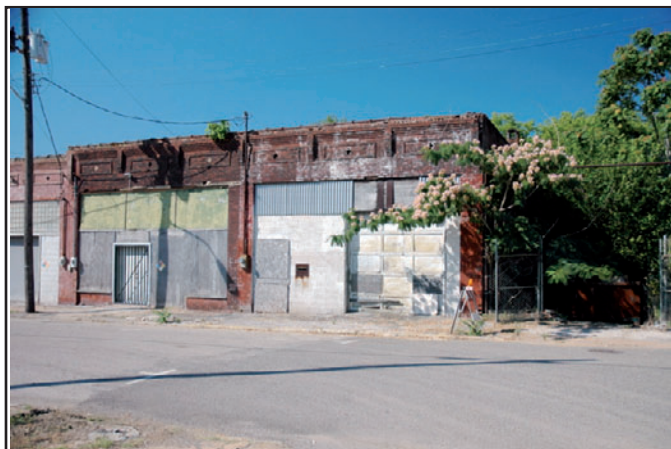
Photo Roll	Neg.	View of:
D015A		Oblique, fac. W
D015B	-C	Details

Rectangular 1-story brick veneer folk Victorian commercial style one-part commercial building with a monopitch roof concealed by flat parapets; faces northeast; façade with two storefront openings separated by a brick pillar; western storefront has been replaced with a concrete block and frame enclosure that includes a cargo entrance and a pedestrian entrance; east storefront retains vestiges of its historic framing and brick bulkheads with a modern entrance and plywood infill; exposed brick veneer at façade with corbelled cornice, decorative brick panels at upper level; northwest elevation is brick; southeast elevation abuts adjacent building; alterations include alterations and infill at all storefronts (ca. 1970).

Construction and design details indicate that this building was constructed circa 1910; a different 2-story store is shown at this site on the 1902 Sanborn map and was labeled "Negro"; this building is shown on the 1911 edition with 2 stores; the 1928 and 1951 editions record the building with three stores; the building is architecturally similar to the adjacent building at 113-115 19th St. suggesting that the two were built at or near the same time.

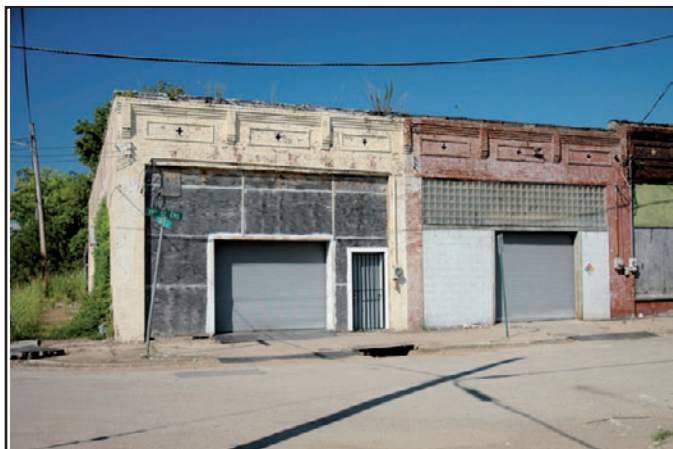
Construction and design details indicate that this building was constructed circa 1910; 3 smaller 1-story stores are shown at this site on the 1902 Sanborn map; this building is shown on the on the 1911 edition with 2 stores; the 1928 and 1951 editions record the building with three stores; the building is architecturally similar to the adjacent building at 101-109 19th St. suggesting that the two were built at or near the same time.

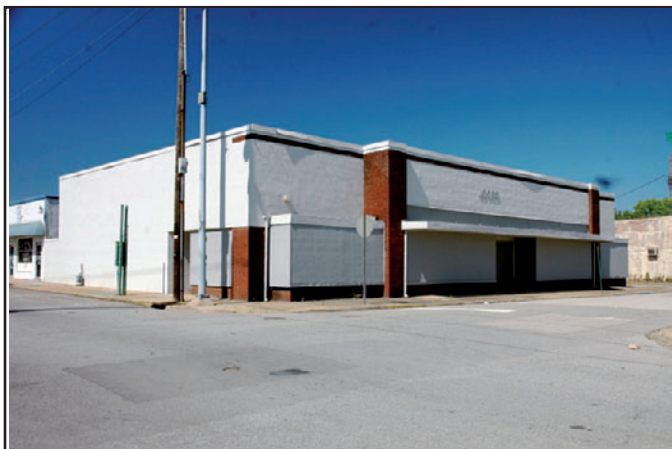
Construction and design details indicate that this building was constructed circa 1945 and was remodeled circa 1990; 4 smaller stores are shown at this site on the 1928 Sanborn map; this building is shown as a furniture store on the 1951 edition.

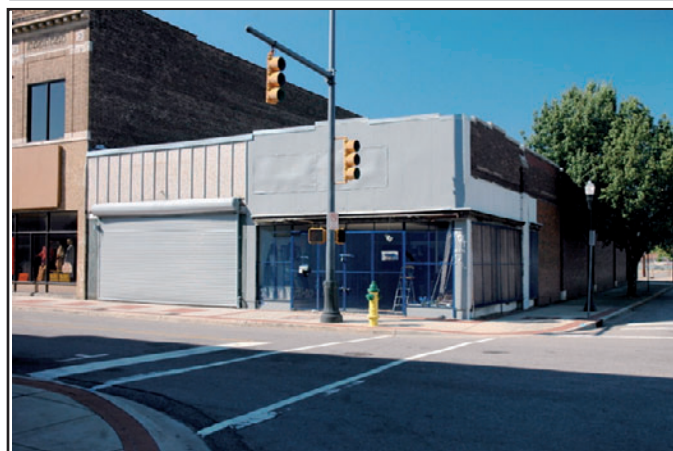
Construction and design details indicate that this building was constructed circa 1925 and that it was remodeled circa 1975; a house is shown at this site on the 1911 Sanborn map; this building is shown on the on the 1928 and 1951 editions as a single building divided into two stores.

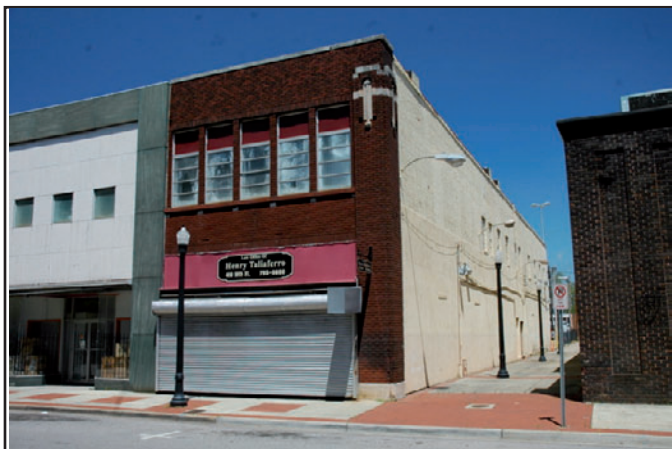
Construction and design details indicate that this building was constructed circa 1925 and that it was remodeled circa 1955 and 1975.

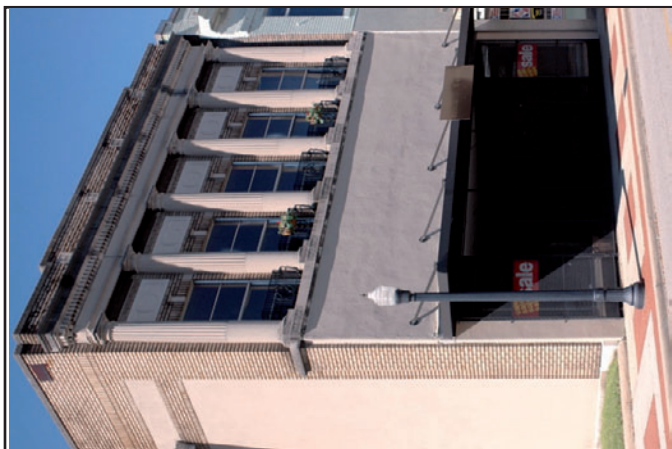
Construction and design details indicate that this building was constructed circa 1925 and that it was remodeled circa 1965

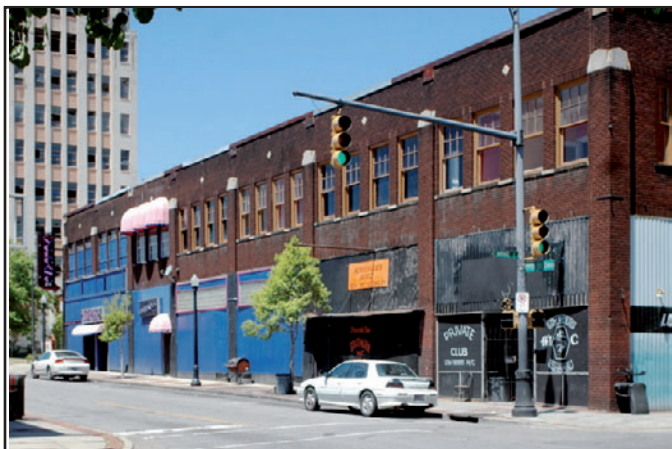
Construction and design details indicate that this building was constructed circa 1927 and that it was remodeled circa 1980. The 1925 city directory listings suggest that the current building was not yet constructed; it is shown on the 1928 edition.

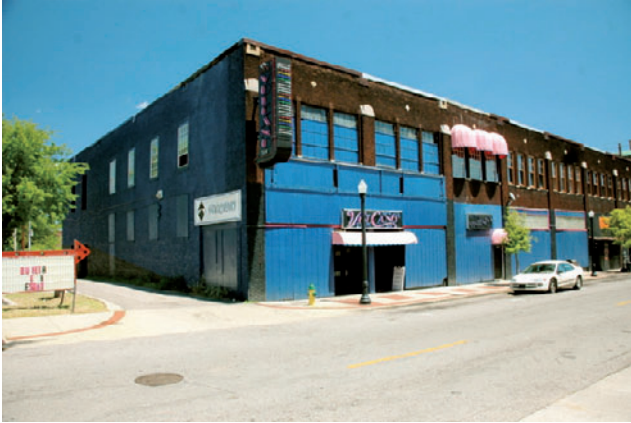
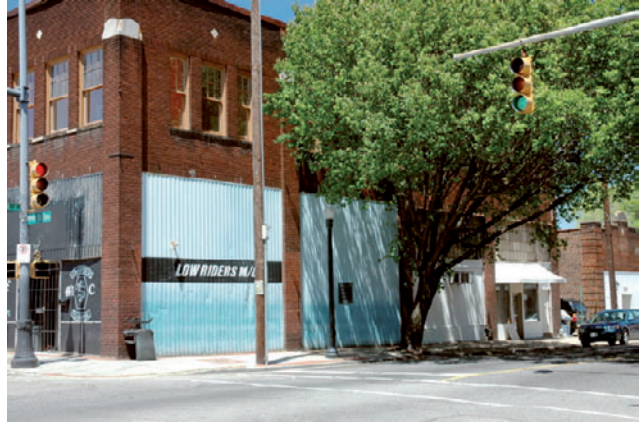
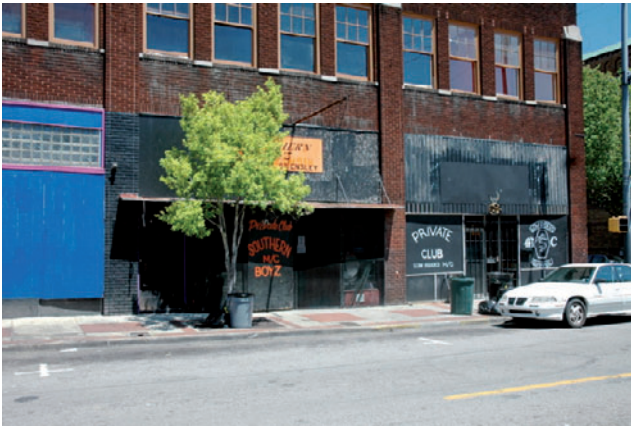
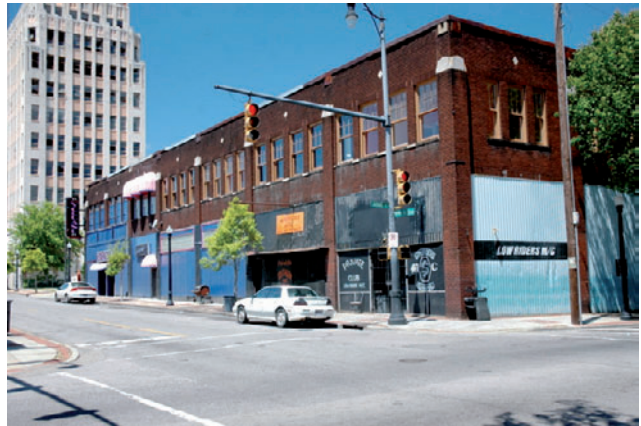
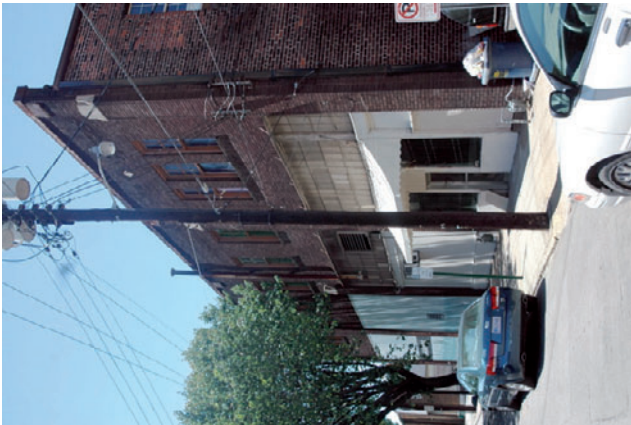
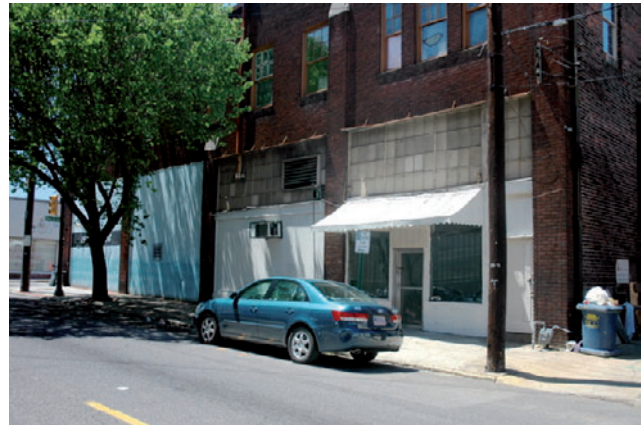
Location: 19th St. Ensley 514 526

Rectangular 1-story brick veneer early twentieth century commercial style one-part commercial block with a monopitch roof concealed by a stepped parapet at its façade and flat parapets at its sides; faces northeast; façade divided into 5 storefront units separated by slightly projecting pilasters that terminate into simple metal caps below the cornice line and have simple stone bases; storefront units have typically been modified with replacement aluminum framing, the addition of various canopies, and the covering of transoms; the façade is exposed brick veneer with 2 small decorative cast diamond inserts within a decorative brick panel with cast corner blocks above each storefront, the west storefront bay has been covered with structural glass; simple metal parapet cap; northwest elevation is exposed along an alley, painted brick with short high-placed windows that have been infilled; southeast elevation abuts an adjacent building; alterations include the addition of structural glass to the west bay (ca. 1935) and modifications to all storefronts (ca. 1960).

Alterations: Date(s): 1935 ca., 1960 ca. Integrity: good Condition: good

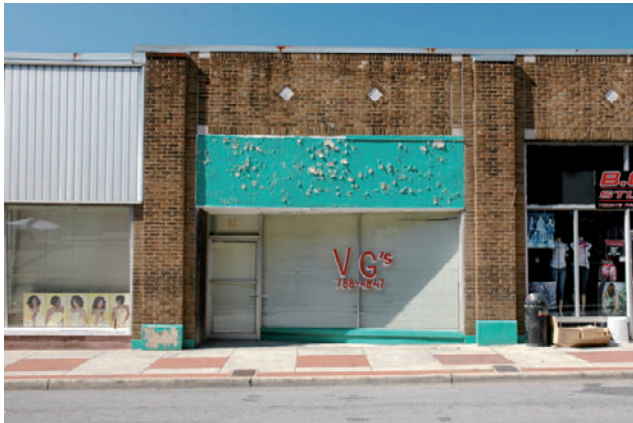
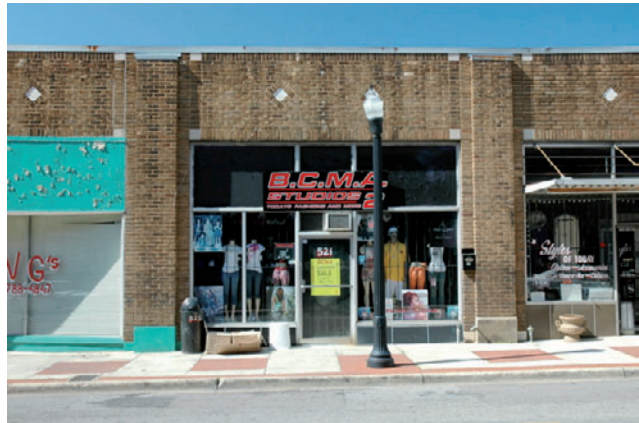
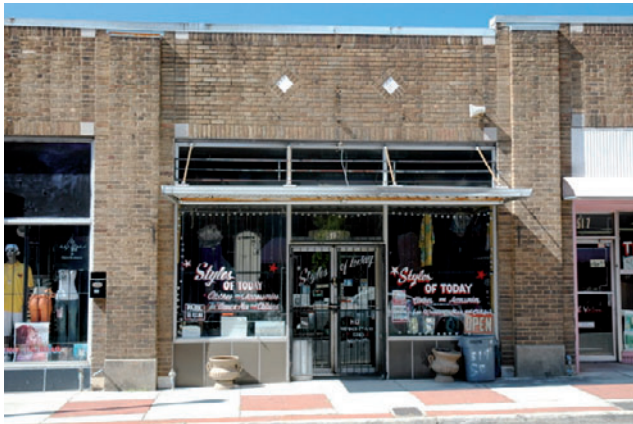
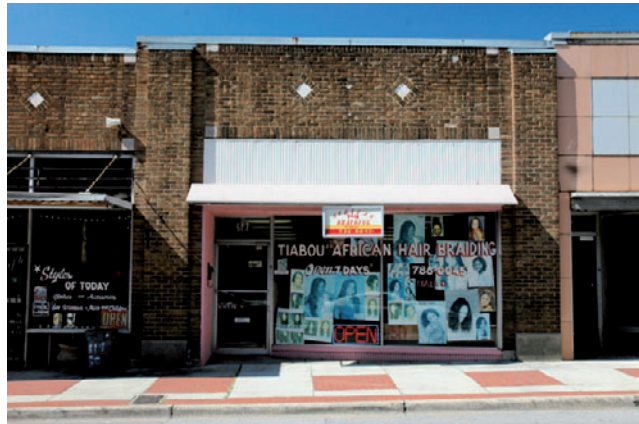
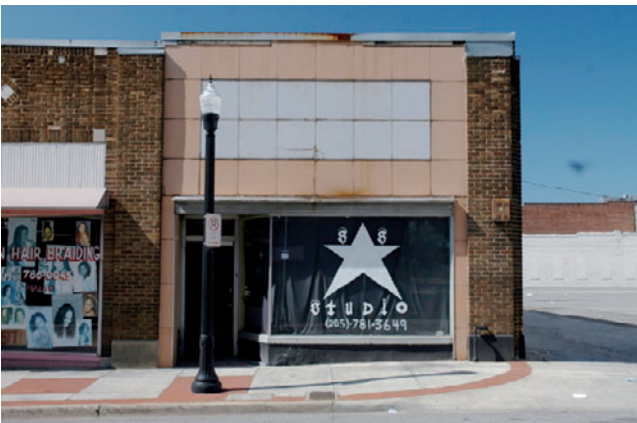
Location: 19th St. Ensley 515 523

Alterations: Date(s): **1955 ca.; 1980 ca.** Integrity: **fair** Condition: **good**
modifications to the storefront (ca. 1955) and the addition of metal siding (ca. 1980).

Construction and design details indicate that this building was constructed circa 1925 and that it was remodeled circa 1955 and circa 1980; while shown on recent sources as a separate building, this building appears to have originally been part of or associated with the adjacent commercial row at 615-619 19th St.

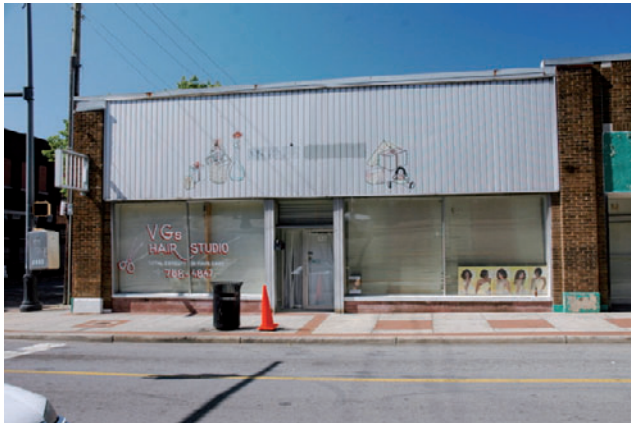
Location: 19th St. Ensley 525

Alterations: Date(s): 1958 ca.; 1960 ca. Integrity: good Condition: good

storefront modifications (ca. 1958) and replacement windows (ca. 1965())

Built in 1910 and historically known as the known as the Knapp Building according to Board of Equalization records; the 1925 city directory lists the Belle Theatre at 602 19th St.; the Belle is not recorded in the 1928 city directory. The building was originally built as a 2-story building with the third floor added in 1927 (Birmingham Post-Herald, 12/14/1927): "The increasing demand for office space in Ensley is being further met by the addition of a third story to the Knapp Building..." Photographs in the BOE records indicate that the building originally had wood 1/1 windows and that the storefront had a central entrance bay framed by wide cast pilasters and 2 storefront systems with a series of tall multi-light transoms. The present storefront is shown in a photograph dated February 1958.

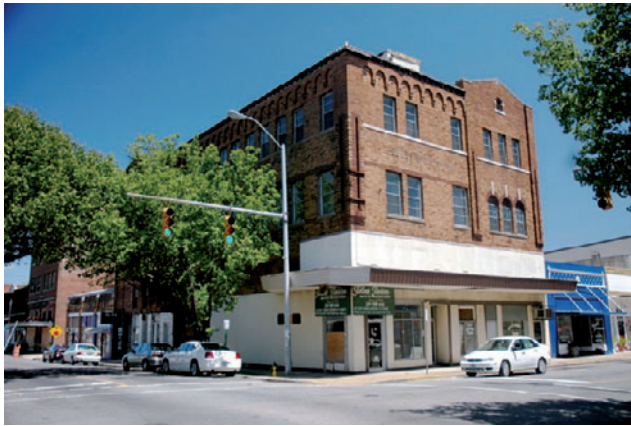
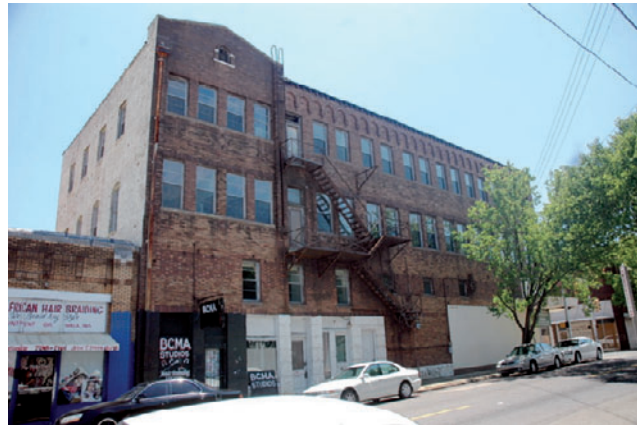
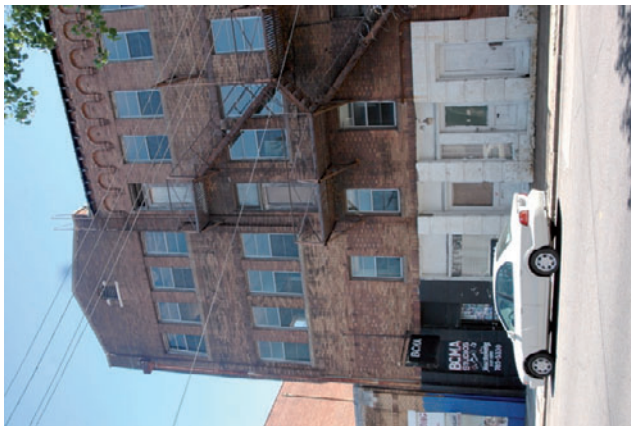
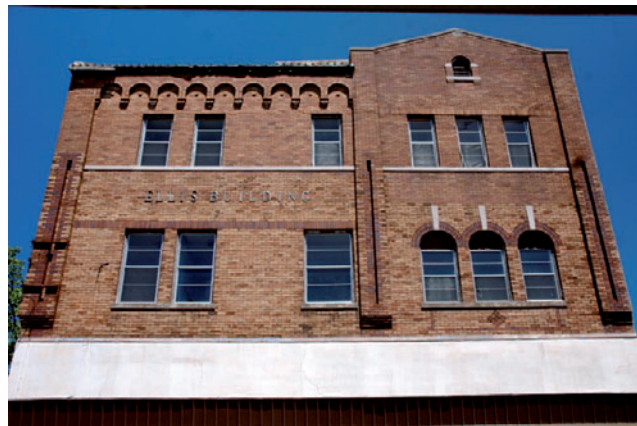
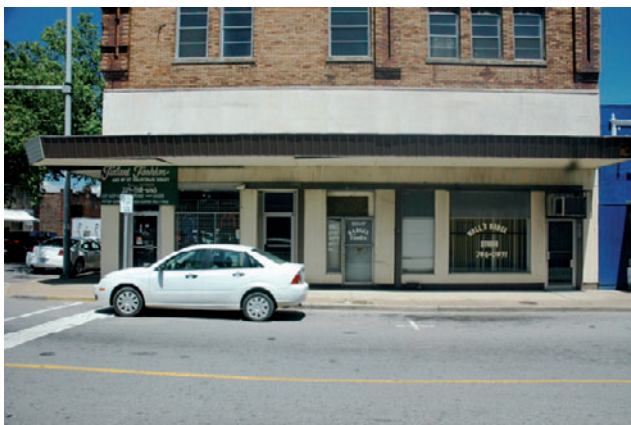
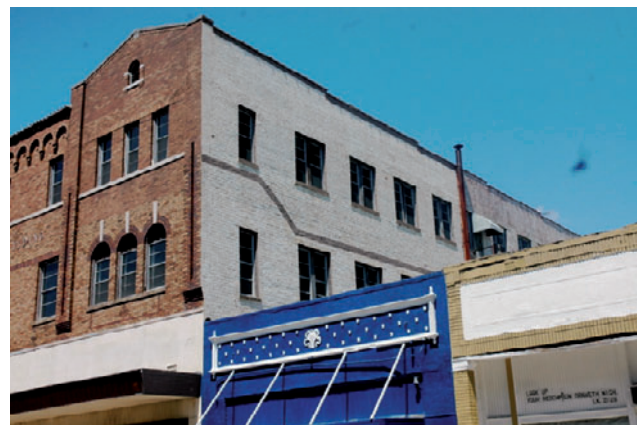
Location: 19th St. Ensley 600 602

Rectangular 2-story brick veneer early twentieth century commercial style two-part commercial block with a monopitch roof concealed by a flat parapet; faces northeast; façade divided into 2 storefront units separated by a brick veneer pillar; storefront units have typically been modified with replacement aluminum framing, the addition of a flat metal canopy, and the covering of transoms; 4 groups of 3 rectangular window openings are spaced across the 2nd floor level, all but one window has been infilled with plywood; the façade is exposed brick veneer with small rectangular attic vents above the center window of each grouping; simple parapet cap; northwest elevation is exposed along an Avenue F and is visually divided by a series of pilasters with molded cast caps that support a narrow cast cornice between the 1st and 2nd levels, a storefront window in the northern bay is flanked to the south by a series of tall single industrial windows, windows similar to those at the façade are spaced along the upper level; the southeast elevation abuts adjacent building; alterations include the modifications to the storefronts (ca. 1960) and the infill of the upper level windows.

Alterations: Date(s): 1960 ca. Integrity: good Condition: good

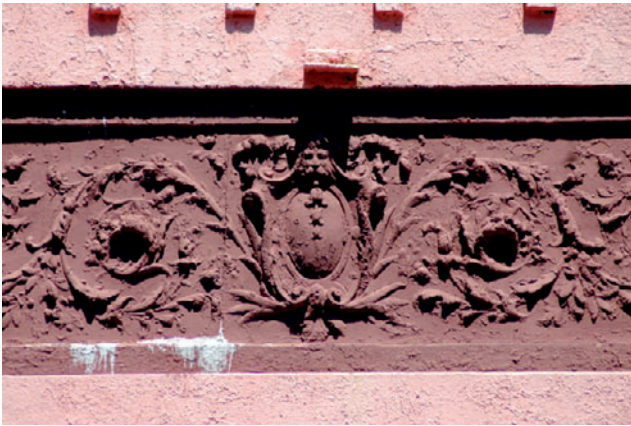
Location: 19th St. Ensley 608

Rectangular 2-story stuccoed two-part commercial building with a modern raised shed roof clad with industrial metal siding (ca. 2000); faces southwest; façade has one storefront flanked to the west by a single entrance, the aluminum-framed storefront has a central double entrance flanked by storefront windows on low bulkheads, the storefront walls have been covered with metal siding, a modern flat canopy extends across the storefront; 4 rectangular window openings are evenly spaced across the upper level and have stucco quoins, lintels, and sills with modern horizontal 2/2 aluminum replacement windows; the façade is painted stucco with a decorative panel along its upper portion; the southeast elevation is exposed along an alley, a storefront window is located in the southern bay of the 1st level with 7 short high-placed windows to the north, 9 rectangular window openings with replacement aluminum windows are unequally spaced along the 2nd level; the northwest elevation abuts an adjacent building; comparison with a circa 1958 photo indicates that alterations include modifications to the storefronts, the installation of replacement windows (ca. 1965), and the addition of an incompatible shed roof system (ca. 2000).

Alterations: Date(s): 1965 ca. Integrity: fair Condition: good

modifications to the storefronts, the installation of replacement windows, and possibly the stucco facade.

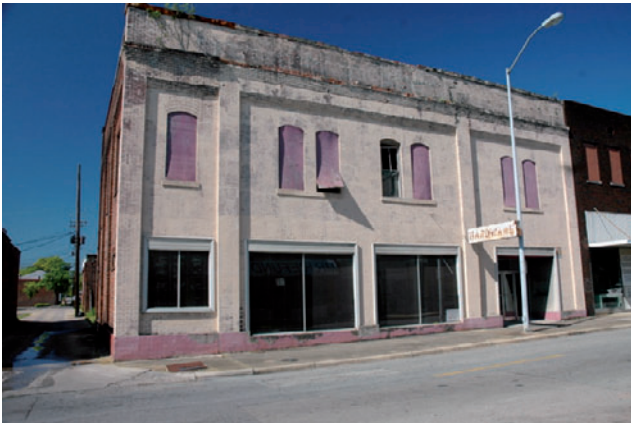
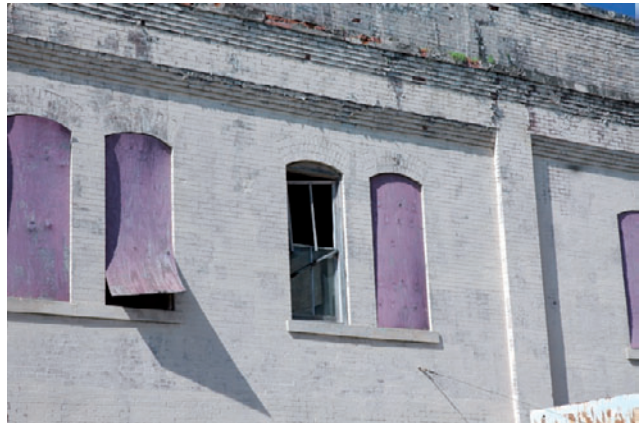
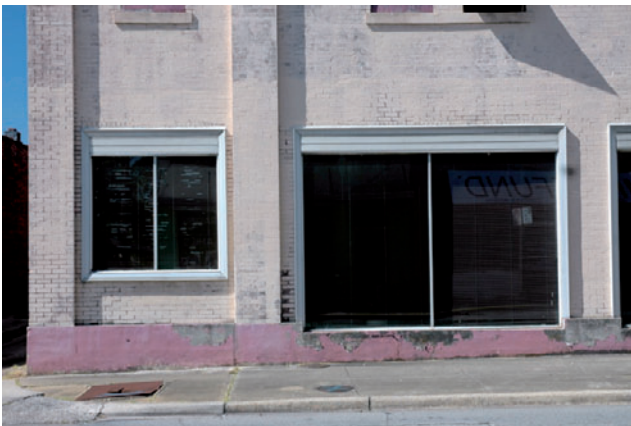
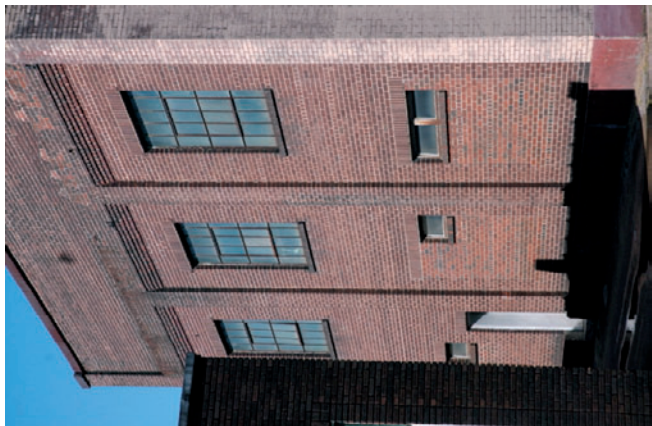
Location: 19th St. Ensley 611

Alterations: Date(s): 1985 ca. Integrity: good Condition: good

Construction and design details indicate that this Early 20th Century Commercial Style commercial row was constructed circa 1927. The building is not listed in the 1925 city directory but is shown on the 1928 Sanborn map. The 1930 city directory lists the following tenants: Tom Jones Dry Cleaning Co., Rogers Inc. grocers, and the Nu-Way clothes cleaners.

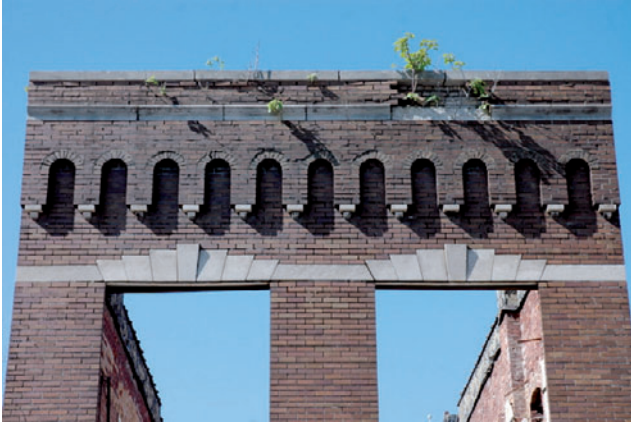
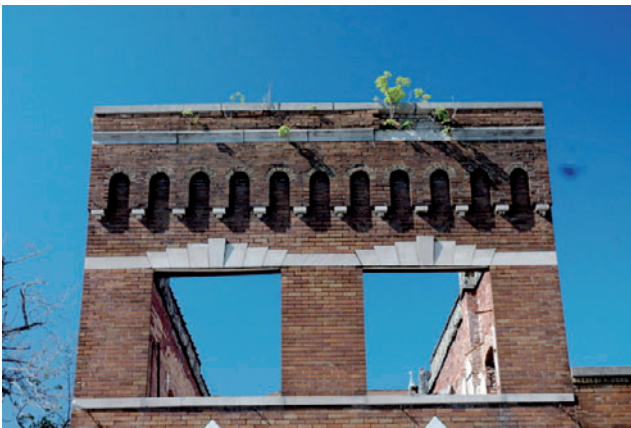
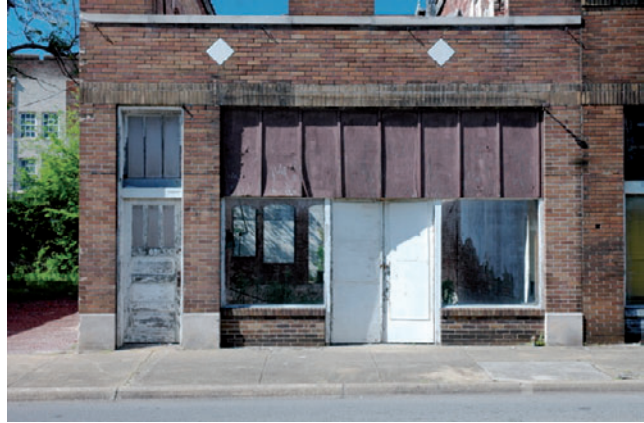
Location: 19th St. Ensley 705

Rectangular 1-story brick veneer early twentieth century commercial style one-part commercial building with a monopitch roof (now collapsed) concealed by a flat parapet; faces northeast; façade has one storefront with a center entrance flanked by storefront windows on low bulkheads, a continuous transom has been covered with plywood, storefront windows and entrance are replacements; the façade is exposed brick veneer with a simple cast parapet cap and 3 decorative cast diamond inserts along its upper level; side elevations abut adjacent buildings; alterations include the modification of the storefront windows and entrance (ca. 1985).

Alterations: Date(s): 1985 ca. Integrity: good Condition: deteriorated

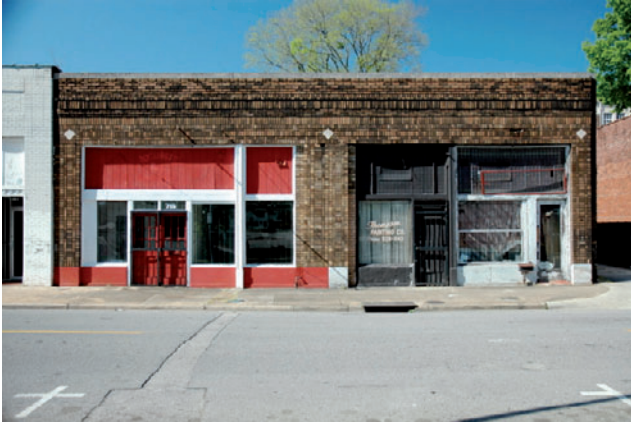
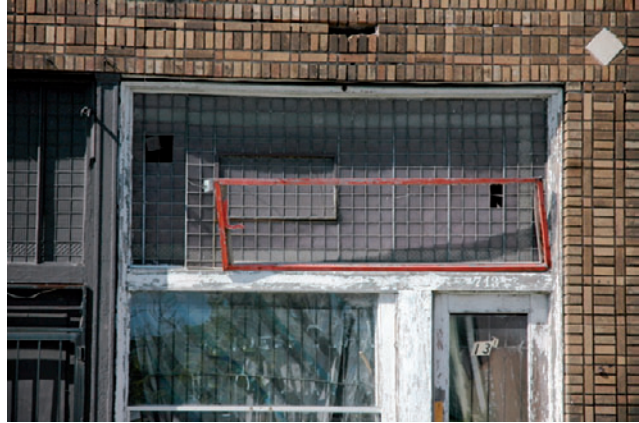
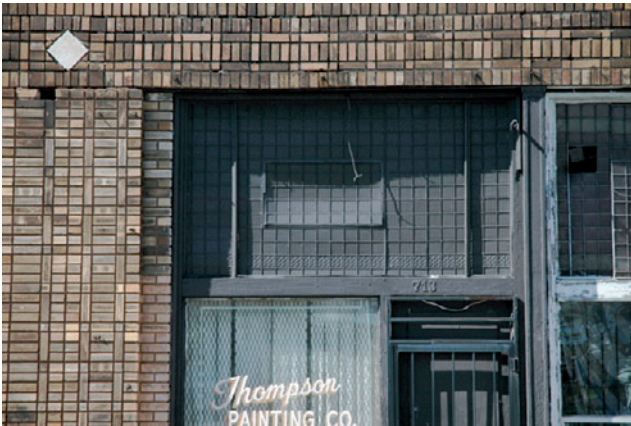
Location: 19th St. Ensley 713 715

Rectangular 1-story brick veneer early twentieth century commercial style one-part commercial building with a monopitch roof concealed by a flat parapet; faces northeast; façade has one storefront system separated into 2 parts by an intermediate metal pillar, each side has a recessed single entrance at its outer bay flanked by a single storefront window on a low brick bulkhead, a continuous transom has been covered with plywood, storefront windows and entrance are replacements; the façade is painted brick veneer with a clay tile parapet cap and 2 decorative recessed panels at its upper level with attic vents centered in each panel; side elevations abut adjacent buildings; alterations include the modification of the storefront windows and entrances (ca. 1970).

Alterations: Date(s): 1970 ca. Integrity: good Condition: good

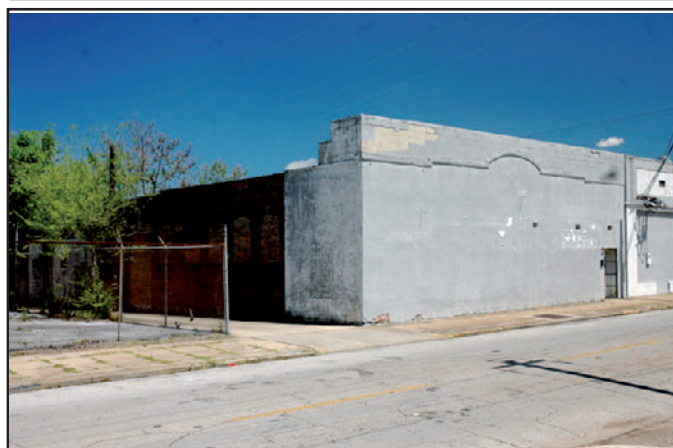
Photo Roll Neg. View of:
D061A Oblique, fac. E

Rectangular 1-story stuccoed brick one-part commercial building with a monopitch roof concealed by a flat parapet at its façade and stepped parapets at its side elevations; faces southwest; façade has been stuccoed over and is a blank wall except for a single entrance at its east side, decorative stucco bands below parapet, parapet appears to be a modern concrete block replacement; northwest elevation is exposed to an alley and (other than the stuccoed front bay) is brick set in common bond with a series of bricked-up windows and doors; the southeast elevation abuts an adjacent building; alterations include the stuccoing of the façade and the replacement of the parapet (ca. 1985); historic architectural integrity lost to alterations.

Alterations: Date(s): 1985 ca. Integrity: poor Condition: good

stuccoing of the façade and the replacement of the parapet

Construction and design details indicate that this building was constructed circa 1925 and that it was remodeled circa 1985.

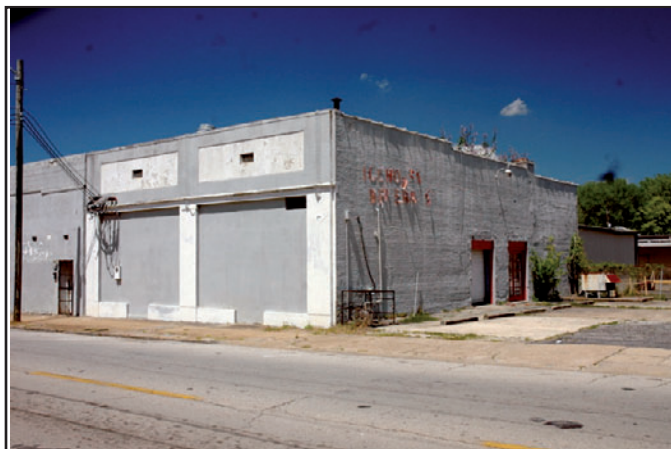
Photo Roll Neg. View of:
D062A **Oblique, fac. N**

Alterations: Date(s): **1985 ca.** Integrity: **fair** Condition: **good**

Construction and design details indicate that this building was constructed circa 1925 and that it was remodeled circa 1985.

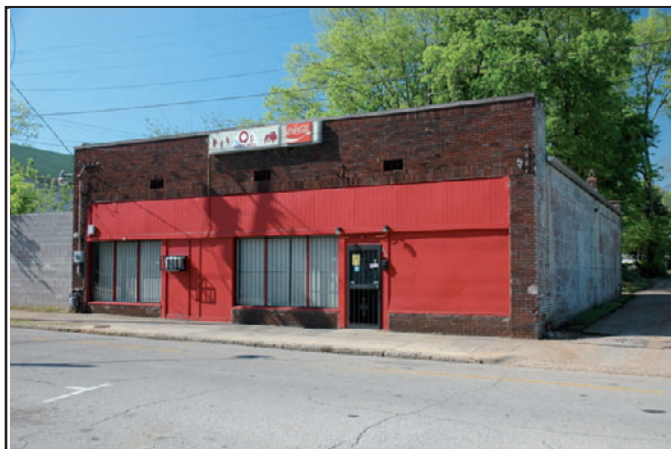
Photo Roll Neg. View of:
D063A , C Oblique, fac. S
D063B Detail

Alterations: Date(s): **1975 ca.** Integrity: **good** Condition: **good**

modifications to the storefronts including some replacement framing elements, the infilling of window, and the infilling of the transom.....

Construction and design details indicate that this building was constructed circa 1925 and that it was remodeled circa 1975.

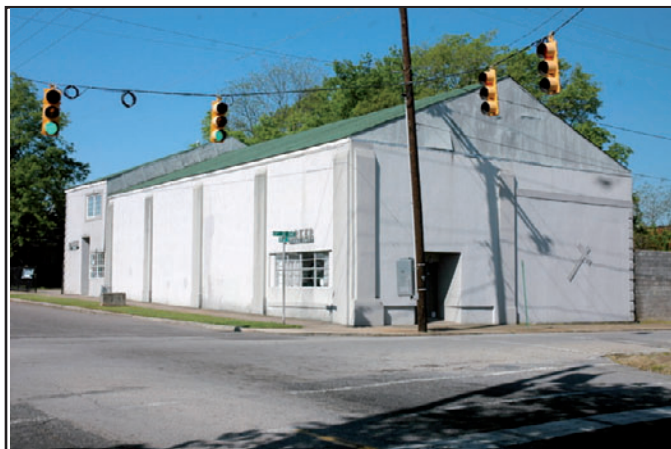
Photo Roll Neg. View of:
D064A Oblique, fac. W

Alterations: Date(s): 1975 ca. Integrity: _____ Condition: _____

Construction and design details indicate that this building was constructed circa 1960 and that it was remodeled circa 1975.

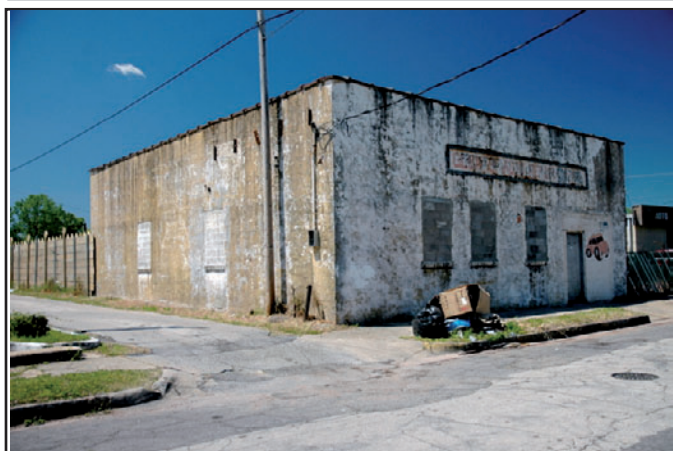
Construction and design details indicate that this building was constructed circa 1925 and remodeled circa 1985; shown as an "Auto Top and Body Repair'g" shop on the 1928 Sanborn map and as a printing shop on the 1951 edition, the site is vacant on the 1911 map.

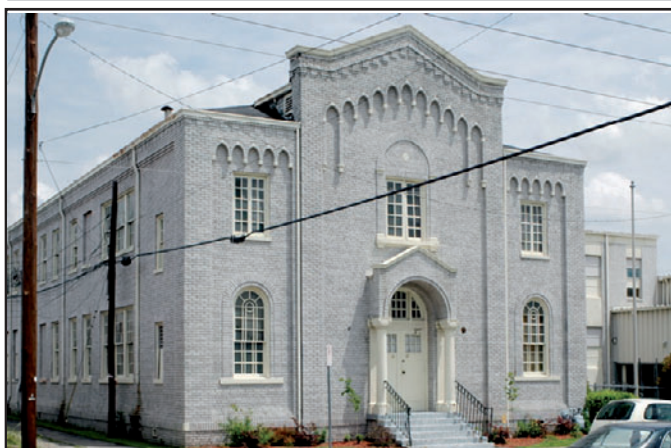
Photo Roll	Neg.	View of:
D076A	-B	Oblique, fac. E
D076C	-D	Details
D076E		Oblique, fac. N
D076F		Oblique, fac. N

Alterations: Date(s): **1965 ca., 2000 ca.** Integrity: **good** Condition: **fair**

Construction and design details indicate that this building was constructed circa 1920 and expanded circa 1965 and circa 2000. The building is shown on the 1928 Sanborn map as the Ensley Presbyterian Church; the site was vacant when the 1911 edition was compiled.

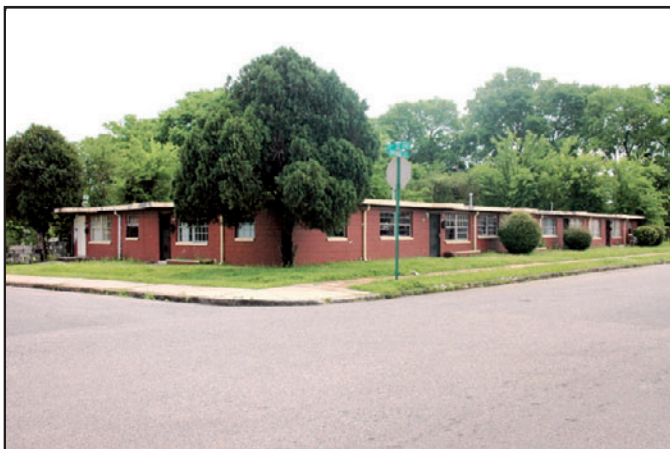
Photo Roll	Neg.	View of:
D077A		Oblique, fac. S
D077B	-C	Details

Alterations: Date(s): **1995 ca.** Integrity: _____ Condition: **good**

replacement of windows

Construction and design details indicate that this building was constructed circa 1955 and expanded circa 1995. The building is not shown on the 1951 Sanborn map; two earlier commercial building are shown along 17th Street and a series of small residences are shown along Ave. C.

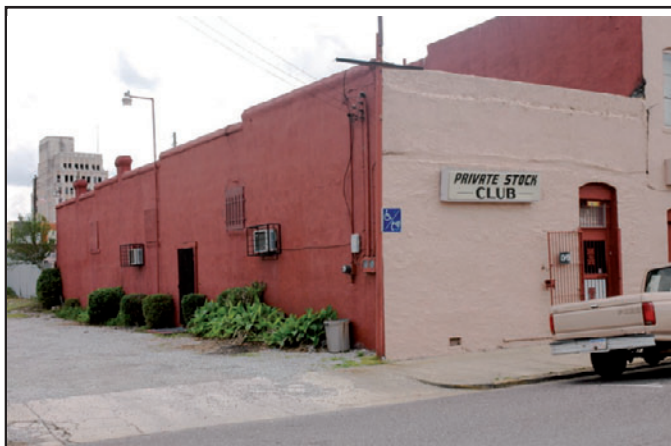
Construction and design details indicate that this building was constructed circa 1910 and that it was remodeled circa 1960. A similar sized 1-story building is shown on the 1902 Sanborn map as a store appears to have been replaced by this building circa 1910. The present building is shown on the 1911 edition as a drug store, on the 1928 edition as a cleaning and pressing facility, and on the 1951 update as a drycleaners.
