ENSLEY

Historic Building Survey

And National Register Nomination - 2008

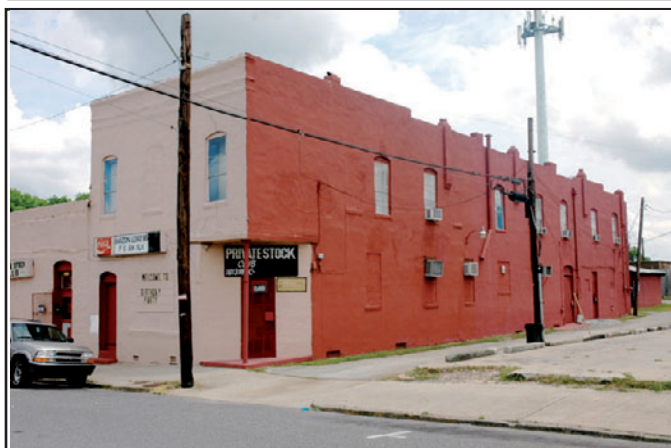
Photo Roll	Neg.	View of:
D080A	-B	Oblique, fac. E
D080C		Oblique, fac. N
D080D	,F	Details
D080E		NE elev., fac. SW

Construction and design details indicate that this building was constructed circa 1900 and that it was remodeled circa 1960. The building is shown on the 1902 Sanborn map as a store with "gambling" at the 2nd floor and a with 1-story rear extension marked "dancing pavilion." The 1911 map indicates that the rear extension had been altered by that time and was on use as beer storage. The 1925 city directory lists the "colored" Knights of Pythias Hall. By 1928, the building is shown as a store with a lodge on the upper level and appears to indicate that the building had been extended to the rear. The building was in use as a restaurant in 1951.

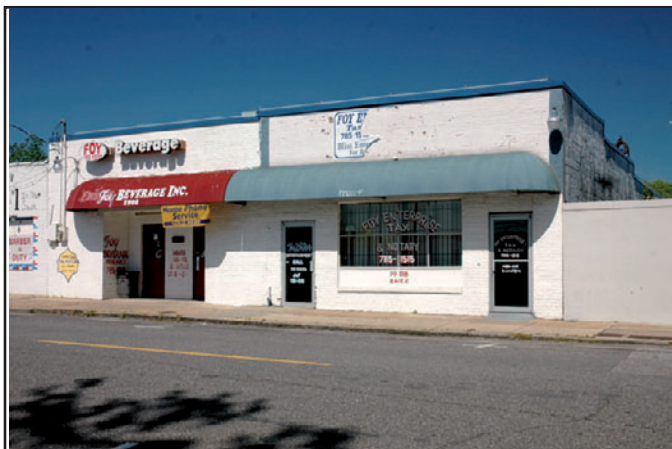
Construction and design details indicate that this building was constructed circa 1940 and that it was remodeled circa 1970. The building is shown on the 1951 Sanborn map with a store in its west unit and a restaurant and a small store at its east unit. An earlier 2-story building is shown on the 1928 map.

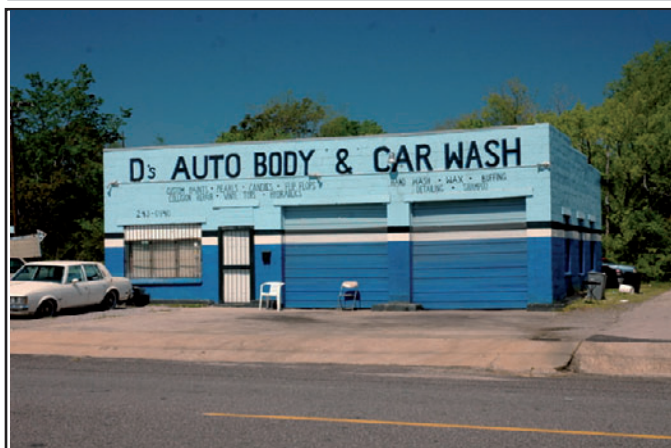
Photo Roll Neg. View of:
D083A **Oblique, fac. W**

Rectangular 1-story concrete block one-part commercial building with a monopitch roof concealed by a flat parapet at its façade and stepped side parapets; faces SE, 2 central garage entrances at its eastern bays flanked by a pedestrian entrance and a storefront window, 3 single industrial metal windows at side elevations; painted concrete block exterior walls; alterations include the partial blocking down of the pedestrian entrance and replacement garage doors (1970 ca.).

Alterations: Date(s): **1970 ca.** Integrity: **good** Condition: **excellent**

partial blocking down of the pedestrian entrance and replacement garage doors

Construction and design details indicate that this building was constructed circa 1950 and that it was remodeled circa 1970. The building is shown on the 1951 Sanborn map as an auto repair shop. The site is shown as being vacant on the 1928 map.

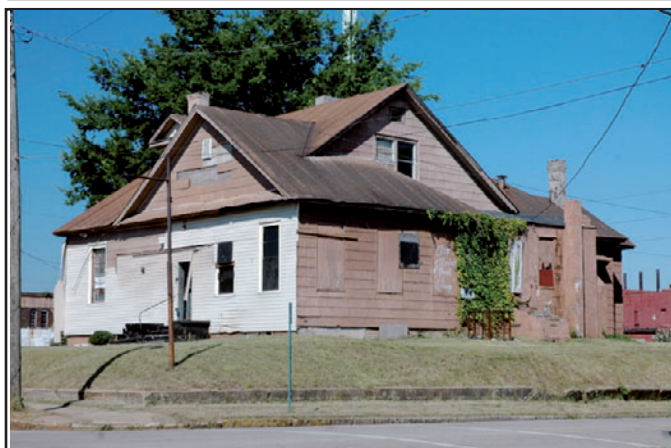
Photo Roll	Neg.	View of:
D086A		Oblique, fac. W
D086B		Oblique, fac. N
D086C		NE elev., fac. SW
D086D	-E	Detail, rear

Rectangular 1.5 story frame folk Victorian style dwelling with a cross gable asphalt shingle roof with pedimented gables and a pedimented gable dormer at the west slope of its front elevation, 3 interior brick chimneys, 1 exterior concrete block chimney, 1 exterior concrete block flue; faces SE, 4x4 bay core with secondary rear gable wing & small additions to the NW; pedimented cross gable above east half, dormer placed high on roof at west half, single off-center entrance with modern replacement door at façade flanked to the east by a small replacement window, single windows at outer bays with replacement aluminum horizontal 2/2 windows; SW elevation with off-center polygonal bay window flanked by replacement windows, NE elevation of core has 4 single windows covered with plywood; similar windows at rear wing and additions; replacement vinyl siding at façade, replacement asbestos shingle siding at remaining elevations; brick pier foundation with infill; alterations include removal of a front bay (ca. 1990), replacement siding (ca. 1990 and ca. 1960), replacement entrance door (ca. 1990), and replacement windows (ca. 1960); small contributing garage to the rear of the house.

Alterations: Date(s): 1960 ca., 1990 ca. Integrity: fair Condition: fair

removal of a front bay, replacement siding, replacement doors and windows

Construction and design details indicate that this building was constructed circa 1895 and that it was remodeled circa 1960 and circa 1990. The building is shown on the 1902, 1911, and 1928 Sanborn maps as a residence and was in use as a restaurant by 1951. The Sanborn maps indicate that the house originally had a projecting bay at the west bay of its façade with a porch that wrapped from the bay to the northeast elevation.

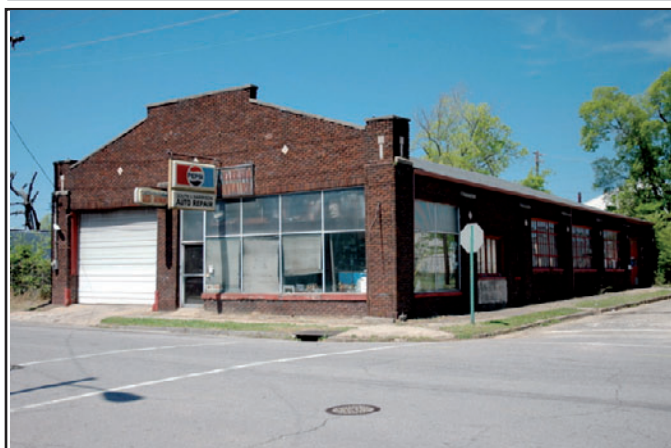
Photo Roll Neg. View of:
D092A -B Oblique, fac. W

Alterations: Date(s): 1975 ca. Integrity: good Condition: good

replacement of the storefront framing with aluminum, the replacement of the front cargo door, and the infilling of 1 side cargo door.

Construction and design details indicate that this building was constructed circa 1925 and that it was remodeled circa 1975. The building is shown on the 1928 Sanborn map as a vacant garage and as auto storage on the 1951 edition.

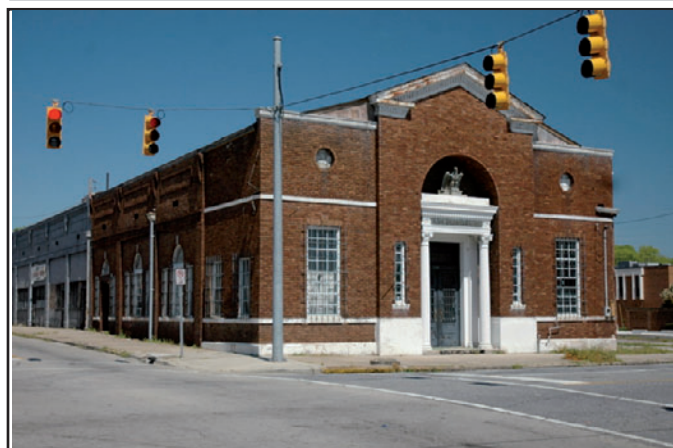
Photo Roll Neg. View of:
 D095A _____ Oblique, fac. N
 D095B _____ Oblique, fac. W
 D095C -D Details

Rectangular 1-story brick veneer Neoclassical Revival style commercial building with a front-facing gable asphalt shingle roof concealed at its façade by a gable parapet; faces SE, 3x5 bay core; central bay of façade projects slightly under broken pedimented gable with a molded cornice with dentils, round-arched central entrance opening with recessed double leaf doors with trabeated entrance surround surmounted by a cast eagle, entrance flanked by single narrow windows; outer bays with single multi-light windows with decorative brick surrounds; similar shorter windows at 2 front bays of SW elevation, 2 similar windows within round arched openings with cast keystones at next 2 bays, similar arched opening with entrance at rear bay; blank NE elevation formerly abutted a building that has been removed; exposed brick veneer façade with decorative cast foundation and belt courses, decorative pilasters and corbelled cornice at SW elevation.

Construction and design details indicate that this building was constructed circa 1925. It is shown on the 1928 Sanborn map as a bank and on the 1951 edition as shops. The Birmingham District indicates that the building was originally the bank of Ensley and that it later served as the Olive Branch Lodge, a social organization for Ensley's white community (pp. 103 & 105).

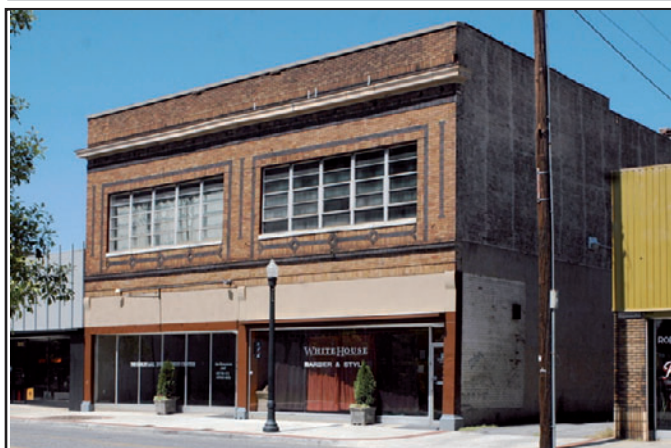
Alterations: Date(s): 1965 ca. Integrity: good Condition: good

replacement of storefront framing with aluminum and replacement windows

Construction and design details indicate that this Early-20th Century Commercial style building was constructed circa 1925. An earlier 1-story commercial building is shown on the 1911 Sanborn map and this building is shown on the 1928 and 1951 editions. The 1925 city directory lists the A.M. Heller dry goods store at 1814 and T. G. Mackey & Sons men's furnishings at 1816 Avenue E, these are the addresses of the property indicated on the 1928 Sanborn map

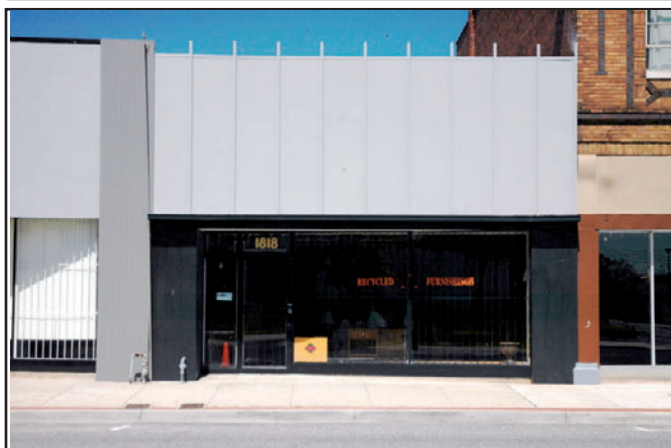
Alterations: Date(s): 1970 ca. Integrity: poor Condition: good

This building is similar in footprint to a building shown on the 1928 and 1951 Sanborn maps but retains no outwardly visible historic integrity.

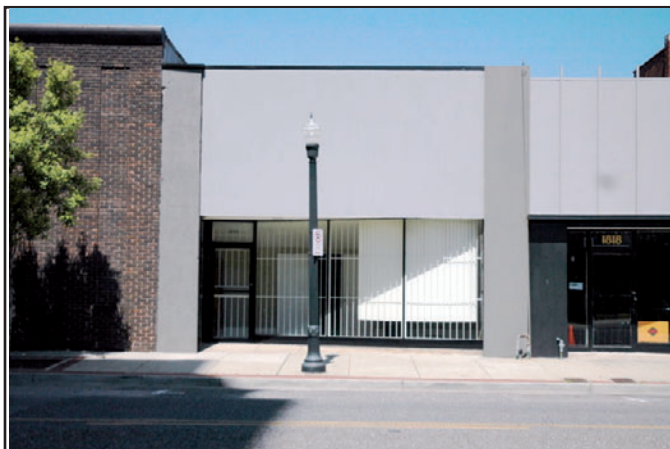
Photo Roll Neg. View of:
D101A Facade, fac. NW

Alterations: Date(s): 1990 ca. Integrity: poor Condition: good

Construction and design details indicate that this building was constructed circa 1925; a house is shown at this site on the 1911 Sanborn map; this building is shown on the on the 1928 and 1950 editions as a store.

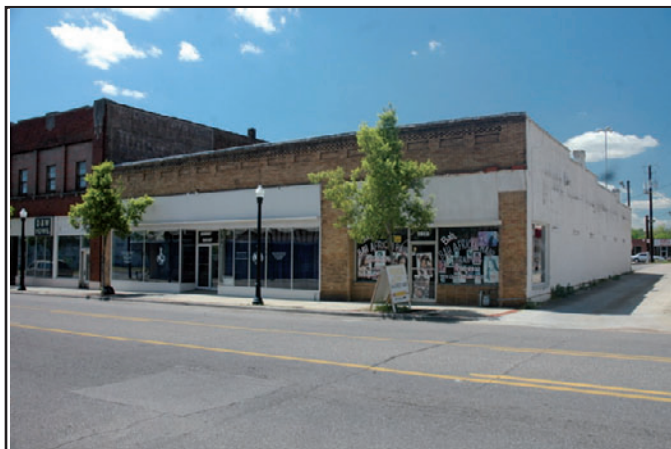
Photo Roll	Neg.	View of:
D102A		Oblique, fac. N
D102B		Facade, fac. NW

Alterations: Date(s): 1970 ca. Integrity: good Condition: good

replacement of storefronts window and doors.

Construction and design details indicate that this building was constructed circa 1910 and that it was remodeled circa 1970. Three small shops are shown on the 1902 Sanborn map. This building is shown on the 1911 edition with 3 shop spaces, the northern space at the time serving as a U.S. Post Office. All 3 spaces were in use as offices at the time the 1928 map was prepared and as shops in 1950.

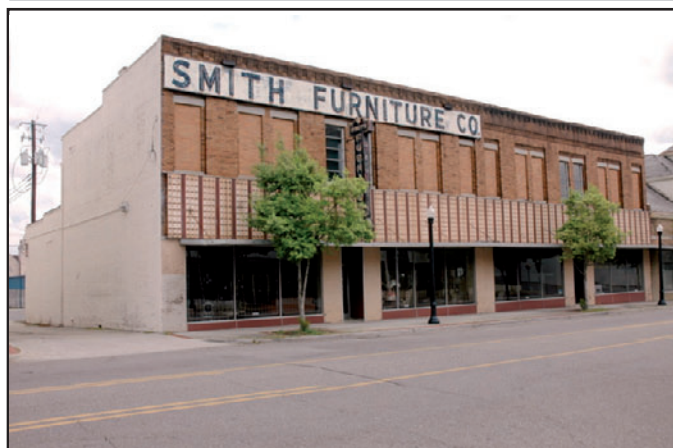
Photo Roll	Neg.	View of:
D103A	-D	Oblique, fac. S
D103E	-F	Details

Alterations: Date(s): 1965 ca. Integrity: fair Condition: good

replacement of storefronts, addition of storefront canopy and decorative metal panels and infill of 2nd level windows

Construction and design details indicate that this building was constructed circa 1910 and that it was remodeled circa 1965. The site is shown as being vacant on the 1902 Sanborn map. This building is shown on the 1910 edition with a "Moving Picture" theatre at its southern retail space, a "Steam Laundry" at its 2nd space, a store in its 3rd space, and a photo shop with a picture framing shop to the rear in its northern space. The 1928 map indicates that the 2 northern spaces had been converted into offices. All 4 spaces were shops at the time the 1950 edition was compiled.

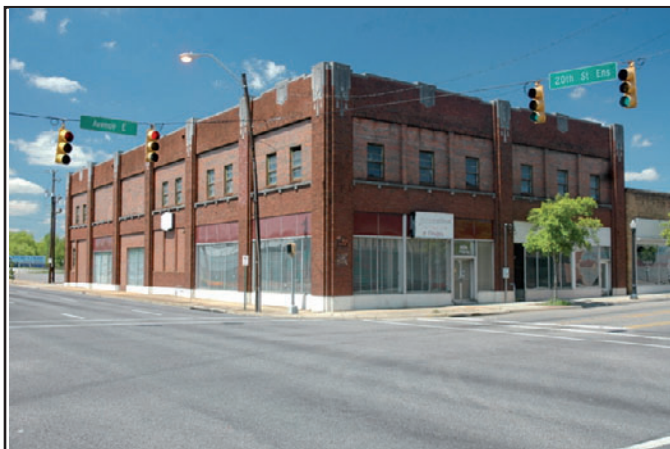
Photo Roll	Neg.	View of:
D104A		Oblique, fac. N
D104B		Facade, fac. NW
D104C		Oblique, fac. E

Alterations: Date(s): 1965 ca. Integrity: good Condition: good

replacement of storefront framing with aluminum and replacement windows (

Construction and design details indicate that this building was constructed circa 1925 and that it was remodeled circa 1965. The ruins of an earlier building and 3 small shops are shown on the 1911 Sanborn map. This building is shown on the 1928 edition as "Ford Sales and Service" and as 2 stores on the 1950 update.

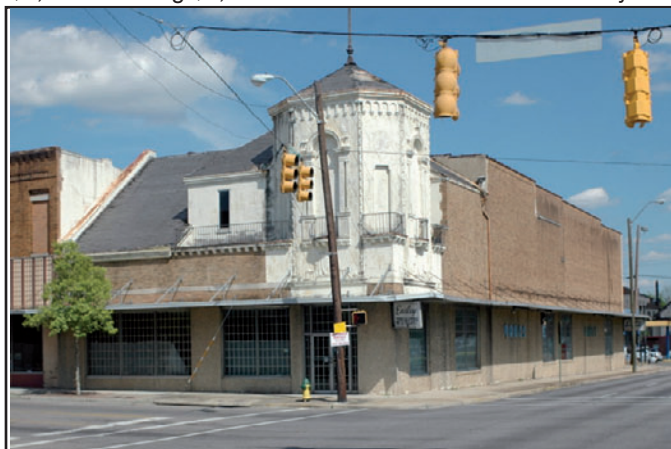
Photo Roll	Neg.	View of:
D105A		Oblique, fac. E
D105B		SW elev., fac NE
D105C		Oblique, fac. S
D105D	-M	Elevations & details

Alterations: Date(s): **1941, ca. 1965** Integrity: **fair** Condition: **good**

This building was built as the Ensley Theatre in 1927 and was designed by architect Lawrence S. Whitten. "Escapism was built into the Ensley's exotic architecture, its ornate stenciled pilasters, stippled walls, its three large chandeliers and three lobbies floored with decorative mosaic tile. The Ensley was built for silent movies, and was outfitted with a large Robert Morton pipe organ [Artful Excursions]. The theatre was extensively remodeled in 1941 [Industrial Press]. The BOE card indicates that the 1941 update included redecorating and the replacement of the deteriorated marquee. It also noted that the owner spent \$5,000 and the theatre (tenant) \$6,000 including \$4,300 for seats and that the tenant's 5-year lease would be \$5,700. The theatre (see continuation sheet)

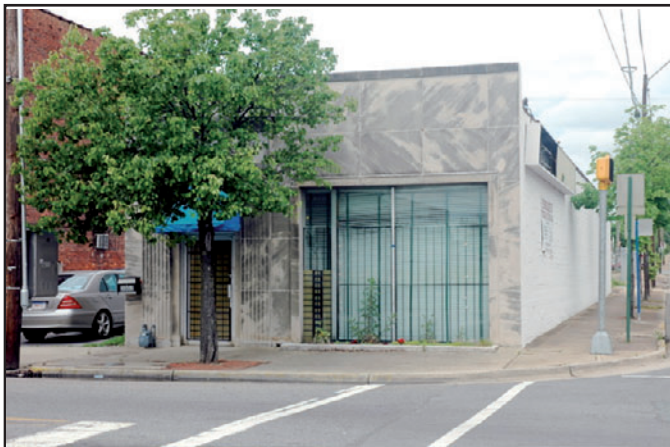
Photo Roll	Neg.	View of:
D106A		Oblique, fac. W
D106B		Oblique, fac. N
D106C		Oblique, fac. NE
D106D		Oblique, fac. SE

Alterations: Date(s): _____ Integrity: good Condition: good

Construction and design details indicate that this building was constructed circa 1955; an earlier 2-story commercial building is shown at this site on the 1950 Sanborn map.

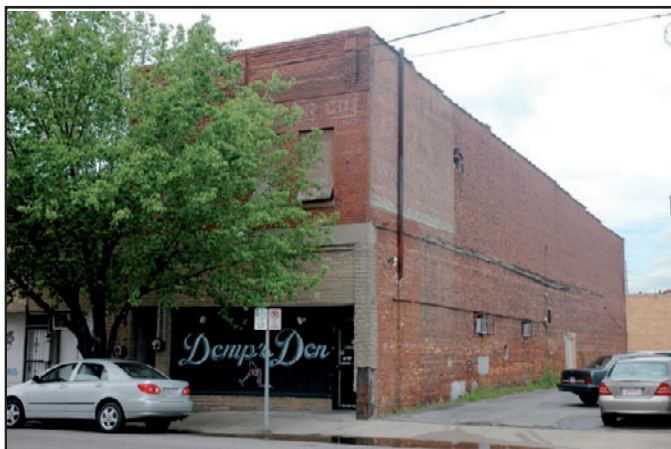
Photo Roll	Neg.	View of:
D107A	-B	Oblique, fac. W
D107C	-E	Facade, fac. NW
D107F		Oblique, fac. E
D107G		Oblique, fac. S

Alterations: Date(s): 1955 ca. Integrity: good Condition: good

covering of the 1st floor of the façade with synthetic stone and the replacement of the storefront system and the infill of windows

Construction and design details indicate that this building was constructed circa 1905 and that it was remodeled circa 1955. The site is shown as being vacant on the 1902 Sanborn map. This building is shown on the 1911 map as a garage, on the 1928 map as an auto repair shop, and on the 1950 map as a used auto sales and service shop.

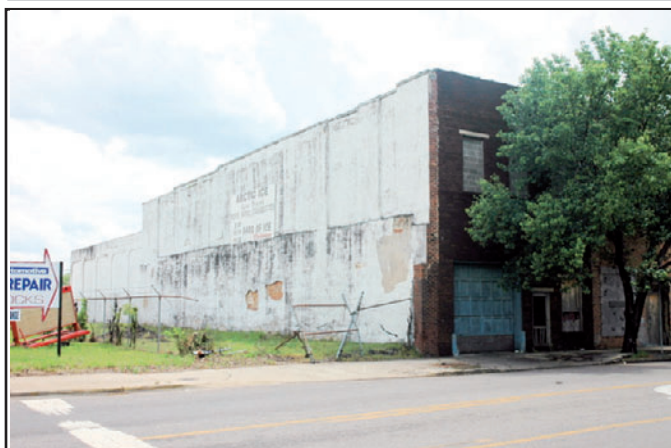
Photo Roll Neg. View of:
 D108A -B Oblique, fac. S
 D108C Oblique, fac. W

Alterations: Date(s): 1970 ca. Integrity: good Condition: good
infill of the 2nd floor windows

Construction and design details indicate that this building was constructed circa 1925 and that it was remodeled circa 1970. The site is shown as being vacant on the 1911 Sanborn map. This building is shown on the 1928 map as part of the Arctic Ice Company complex that included the adjacent building to the southwest. The map indicates that the company manufactured ice and ice cream. The front portion of the building was used for auto repairing and loading and the rear portion housed refrigeration equipment. The 1950 map shows the building in the same use under the name Puro Ice Cream Co.

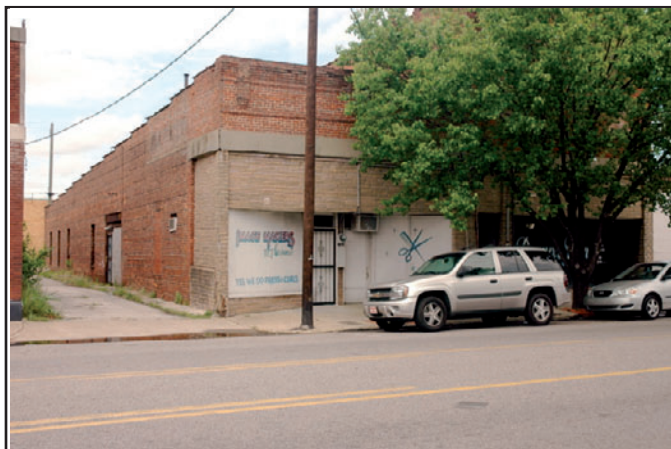
Photo Roll	Neg.	View of:
D109A	-C	Oblique, fac. N
D109D		Oblique, fac. W
D109E	-F	Oblique, fac. E
D109G		Detail

Alterations: Date(s): 1955 ca. Integrity: good Condition: good

covering of the 1st floor of the façade with synthetic stone and the replacement of the storefront system

Construction and design details indicate that this building was constructed circa 1925 and that it was remodeled circa 1955. The site is shown as being vacant on the 1911 Sanborn map. This building is shown on the 1928 map with an office to the front and joined at the rear to the adjacent building to the northeast as an auto repair shop. The 1950 map shows the building as a used auto sales and service shop.

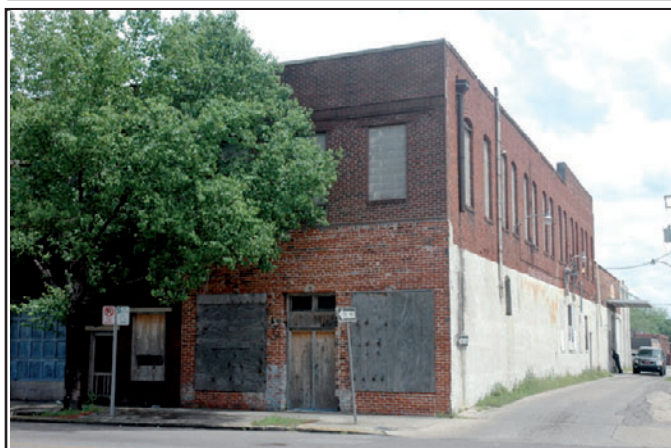
Photo Roll Neg. View of:
 D110A , C Oblique, fac. E
 D110B Facade, fac. SE

Alterations: Date(s): 1930 ca., 1970 ca. Integrity: good Condition: good
 present brick façade appears to date from circa 1930, alterations include the infill of the 2nd floor windows

Construction and design details indicate that this building was constructed circa 1910 and that it was remodeled circa 1930 and circa 1970. An earlier 1-story commercial building is shown at this site on the 1902 Sanborn map. This building is shown on the 1911 map as a store. By the 1928 map, it was part of the Atlantic Ice Company complex that included the adjacent building to the northeast. The map indicates that the company manufactured ice and ice cream. The front portion of the building was the ice cream factory. The 1950 map shows the building in the same use under the name Puro Ice Cream Co.

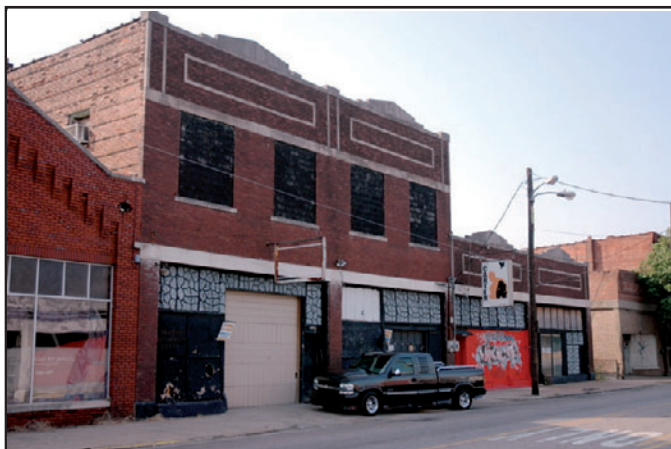
Photo Roll	Neg.	View of:
D111A		Oblique, fac. W
D111B	-C	Oblique, fac. N
D111D		Facade, fac. NW
D111E	L	Details, rear

Alterations: Date(s): 1970 ca. Integrity: good Condition: good

Construction and design details indicate that this building was constructed circa 1925 and that it was remodeled circa 1970. This site is shown as being vacant on the 1911 Sanborn Map. This building is shown on the 1928 map a Hudson-Essex auto dealership with a dance hall at the 2nd floor. The building was still used for auto sales and service in 1950 with a "Hall" upstairs.

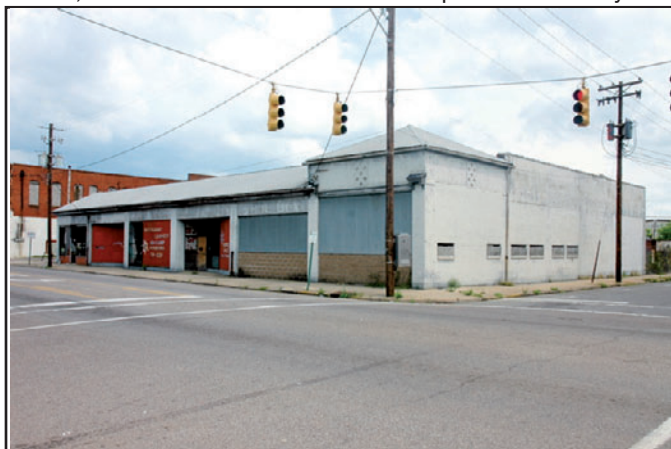
Photo Roll	Neg.	View of:
D112A	C	Oblique, fac. E
D112B		Oblique, fac. S
D112D	-F	Details
D112G		Rear elevation

Rectangular 1-story brick veneer early twentieth century commercial style one-part commercial row with dual pitched asphalt shingle roof concealed by parapets at its side elevations, hipped corner pavilion; faces NW; façade with 6 storefront units separated and flanked by brick pillars; 2 southern storefronts have been infilled, remaining storefronts have replacement aluminum windows and doors; upper façade covered with stucco with simple boxed cornice; SW elevation exposed along 21st St. and is painted brick set in common bond with the corner pavilion to the west and a flat parapet with clay tile cap to the east, six low windows infilled with plywood; NE elevation is exposed brick set in common bond with a stepped parapet with clay tile cap, no openings; alterations have included the infilling of 2 storefronts and replacement of remaining storefront windows and doors (1970 ca.).

Alterations: Date(s): 1970 ca. Integrity: good Condition: fair
the infilling of 2 storefronts and replacement of remaining storefront windows and doors.

Construction and design details indicate that this building was constructed circa 1927 and that it was remodeled circa 1970. The present building is located on the site of Ensley's City Hall and Opera House. The 1902 Sanborn map indicates that the building was a 2-story L-shaped building with a market on the 1st floor and the opera house on the second of the main portion along Avenue E and city offices and jail in a wing along 21st Street. By the 1911 Sanborn map, the market had been replaced by a fire department with 7 men, 2 horses, and 1 auto. The present building is shown on the 1928 map with a drug store in the southernmost of its 4 retail units, 2 stores, and a auto sales and service shop to the north. By 1950, the drug store had become a restaurant.

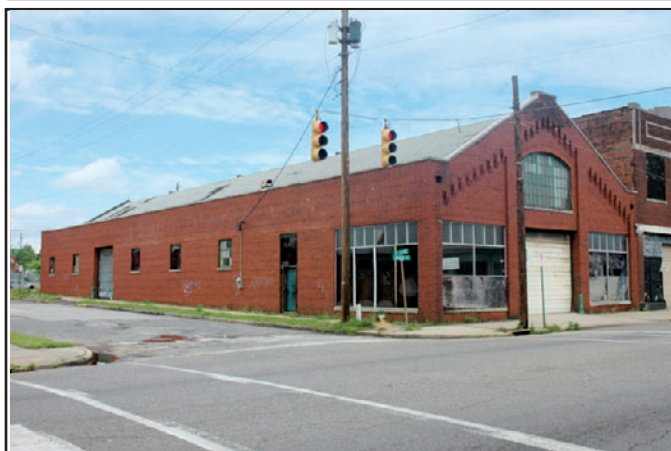
Photo Roll	Neg.	View of:
D113A		Oblique, fac. N
D113B		Facade, fac. NW
D113D		Oblique, fac. E
D113C		,E,F Details

Alterations: Date(s): 1975 ca. Integrity: good Condition: fair

Construction and design details indicate that this building was constructed circa 1915 and that it was remodeled circa 1970. Two dwellings are shown at the rear of this site on the 1911 Sanborn Map. The present building is shown on the 1928 edition as an automobile repair shop and on the 1950 edition as a used auto sales and service shop.

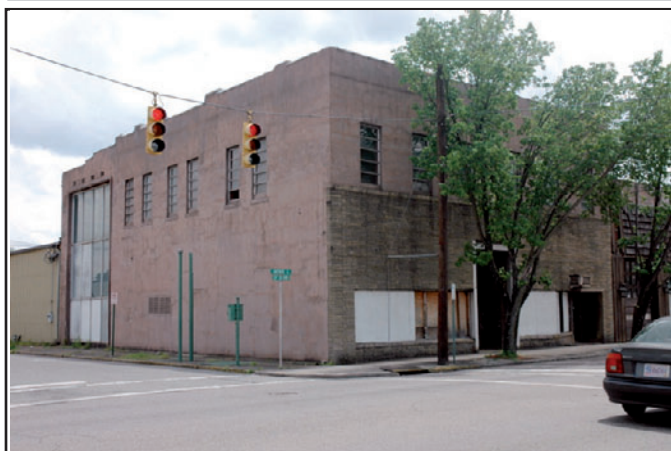
Photo Roll	Neg.	View of:
D114A		Oblique, fac. S
D114B		Facade, fac. SE
D114C		Oblique, fac. S

Rectangular 2-story stucco two-part commercial building with a monopitch roof concealed by a flat parapet at its façade and stepped parapets at its sides; faces NW; lower level has been covered with synthetic stone and has a large recessed central entrance flanked to the north by a long storefront window that has been infilled and to the south by a similar storefront with a secondary entrance at its south end; stuccoed 2nd floor level has 6 rectangular window openings with replacement aluminum windows; similar windows at 2nd level of NE elevation, large full-height modern aluminum window system at rear bay; SW elevation abuts an adjacent building; alterations include the application of synthetic stone and stucco, replacement of all windows and entrances (1965 ca.)

Alterations: Date(s): **1965 ca.** Integrity: **fair** Condition: **good**

application of synthetic stone and stucco, replacement of all windows and entrances

Construction and design details indicate that this building was constructed circa 1910 and that it was remodeled circa 1965. The site is shown as being vacant on the 1902 Sanborn Map. The present building is shown on the 1911 edition with 2 shops, on the 1928 map with 1 store, and on the 1950 map as an auto sales and service business.

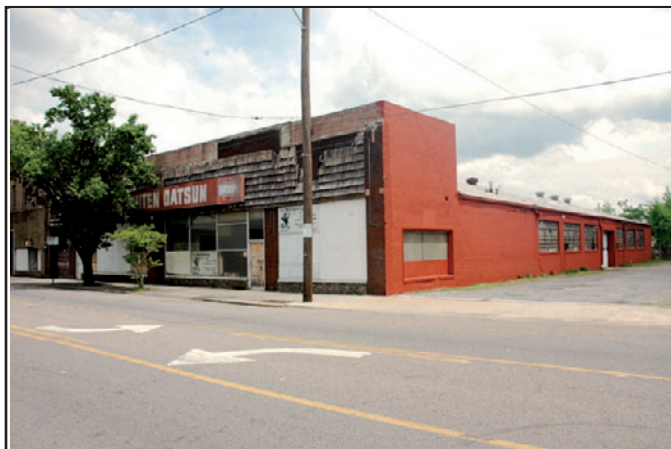
Photo Roll	Neg.	View of:
D115A		Oblique, fac. E
D115B		Oblique, fac. S

Alterations: Date(s): 1970 ca. Integrity: fair Condition: fair

replacement of storefront windows and doors and the application of wood shingles to the façade

Construction and design details indicate that this building was constructed circa 1925 and that it was remodeled circa 1970. This site is shown as being vacant on the 1911 Sanborn map. A building that appears to be the SW portion of the present building is shown on the 1928 edition as an auto sales and service facility. A gas and battery service station is shown to the NE. The building is shown in its present configuration on the 1950 map as an auto sales and service business.

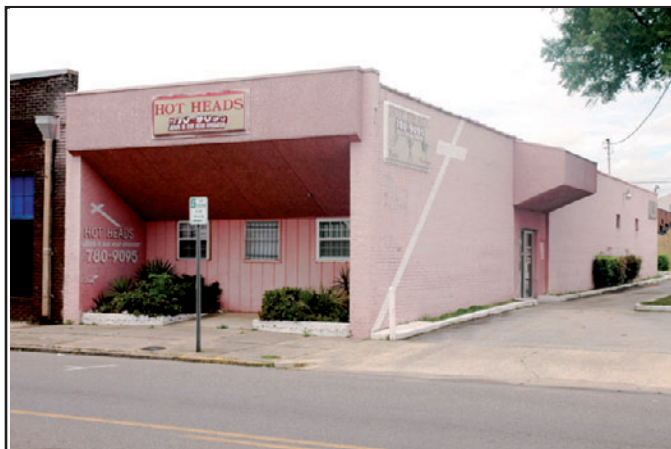
Photo Roll Neg. View of:
D116A _____ Oblique, fac. W
D116B _____ Facade, fac. NW

Rectangular 1-story brick enfamed window wall commercial building with a front monopitch roof concealed by flat parapets; faces SE; façade has a single recessed storefront system that has been replaced with a frame enclosure clad with plywood siding and containing 3 modern aluminum windows; stucco sign panel at upper façade; off-center entrance at NE painted brick elevation with modern canopy, 2 small windows; SW elevation abuts adjacent building; alterations include the storefront enclosure and stucco work (1990 ca.).

Alterations: Date(s): 1990 ca. Integrity: poor Condition: fair

Construction and design details indicate that this building was constructed circa 1950 and that it was remodeled circa 1990. An earlier commercial building is shown on the 1928 Sanborn map and this building is shown on the 1950 update.

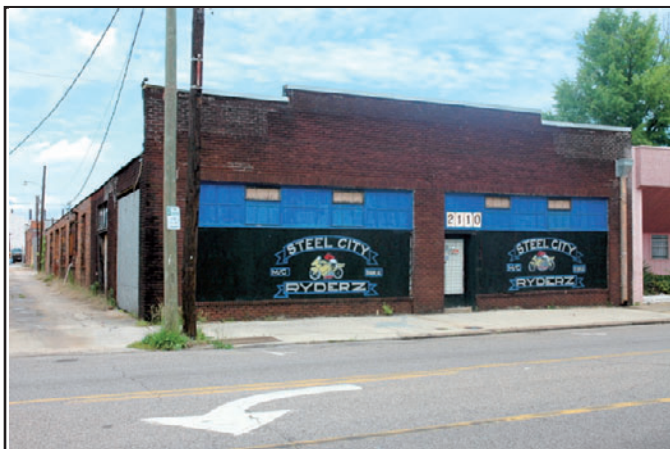
Photo Roll	Neg.	View of:
D117A		Oblique, fac. N
D117B		Facade, fac. NW
D117C		Oblique, fac. N

Alterations: Date(s): **1990 ca.** Integrity: **good** Condition: **good**

Construction and design details indicate that this building was constructed circa 1925 and that it was remodeled circa 1990. This site is shown as vacant on the 1902 and 1911 Sanborn maps. The present building is shown on the 1928 and 1950 editions as an automobile sales and service facility.

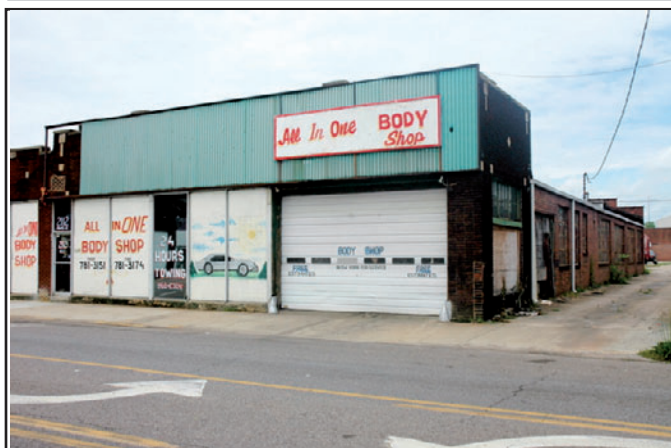
Photo Roll Neg. View of:
D118A -B Oblique, fac. E
D118C Oblique, fac. E

Construction and design details indicate that this building was constructed circa 1925 and that it was remodeled circa 1970. This site is shown as vacant on the 1902 and 1911 Sanborn maps. The present building is shown on the 1928 edition as an automobile sales and service facility with a showroom at the front. The building was in use as a machine shop by 1950.

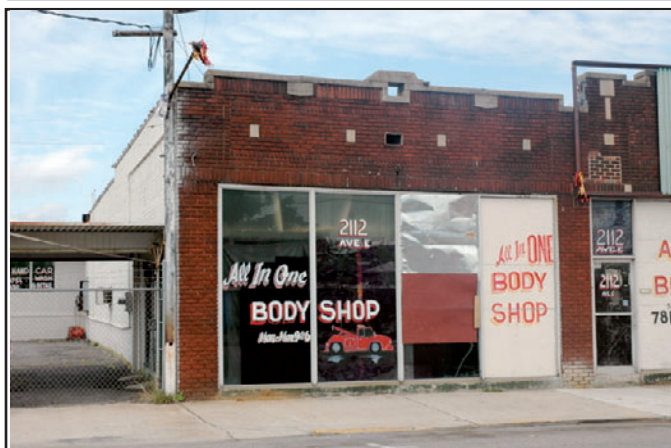
Photo Roll Neg. View of:
D119A Oblique, fac. S

Construction and design details indicate that this building was constructed circa 1925 and that it was remodeled circa 1970. This site is shown as vacant on the 1902 and 1911 Sanborn maps. The present building is shown on the 1928 edition as an automobile repair shop. By 1950, the building had been incorporated into the auto sales and service business operating out of the adjacent building at 118 Avenue E.

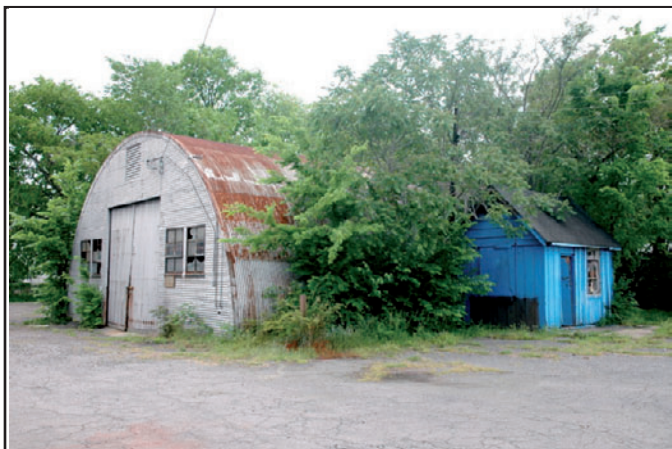
Photo Roll	Neg.	View of:
D120A		Oblique, fac. S
D120B		Oblique, fac. S (shown)

Construction and design details indicate that this building was constructed circa 1945 but it was not located on this site until after 1950 according to the Sanborn map of that year.

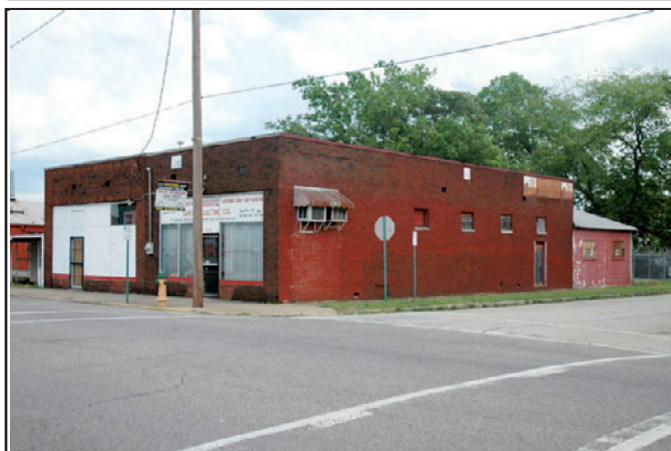
Photo Roll	Neg.	View of:
D121A		Oblique, fac. N
D121B		Facade, fac. SE
D121C		Oblique, fac. W

Construction and design details indicate that this building was constructed in two phases: the NE section circa 1925 and the SW section by 1928 and that both sections were remodeled circa 1970. A small house and a small store were shown at this site on the 1911 Sanborn Map. Both portions of the building are shown on the 1928 map: the NE section as a dry cleaners and the SW section as a shop. Both sections are shown as separate stores in 1950.

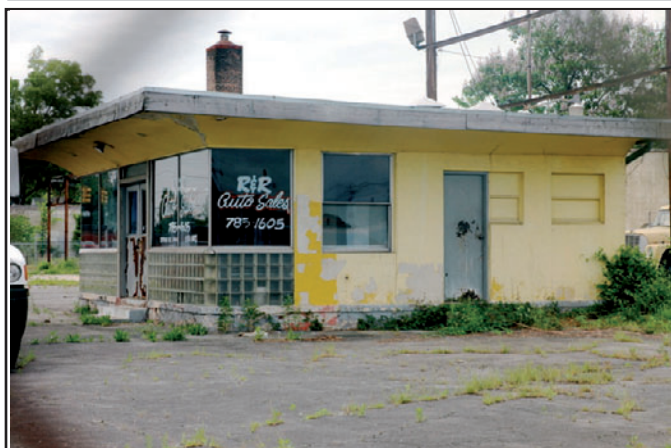
Photo Roll	Neg.	View of:
D123A		Oblique, fac. W
D123B		Oblique, fac. S

Rectangular 1-story stucco commercial building with a monopitch roof; faces SE; façade with central entrance with double doors and transom flanked by storefront windows on high glass block bulkheads; side elevations with single horizontal 2/2 aluminum windows and pedestrian entrances; wide overhanging eaves at roof with curved soffits, painted stucco exterior walls, slightly raised concrete slab foundation.

Construction and design details indicate that this building was constructed circa 1955. This portion of the site is shown as being vacant on the 1950 Sanborn map. The property was at the time the used auto lot for the Drennen Motor Car Company and this building appears to have been built as an office for that business.

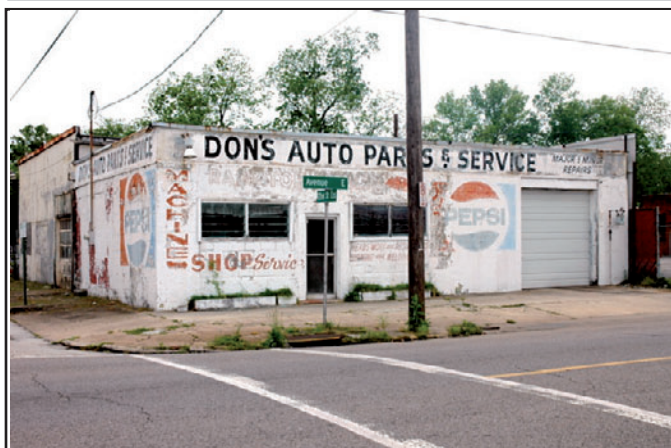
Photo Roll	Neg.	View of:
D124A		Oblique, fac. S
D124B		Oblique, fac. E
D124C		Oblique, fac. S

Construction and design details indicate that this building was constructed circa 1955. The rear portion of the building may be part of a gasoline station that was shown on the 1950 Sanborn map; the front portion is not shown.

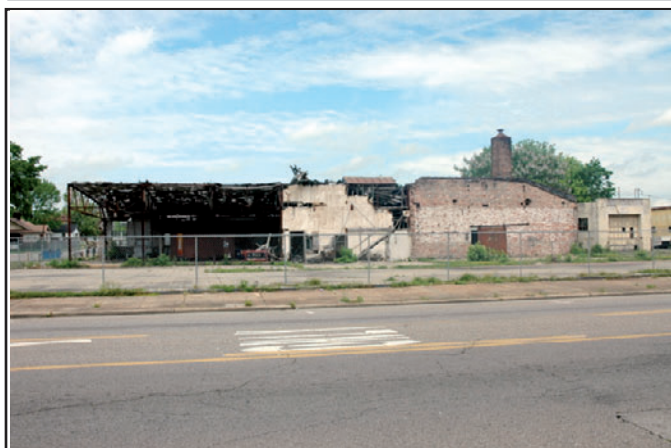
Photo Roll Neg. View of:
D127A _____ Oblique, fac. NW
D127B _____ Oblique, fac. NE

Alterations: Date(s): 2000 ca. Integrity: poor Condition: ruin

Construction and design details indicate that this building was constructed circa 1935. The original building extended to Avenue E and historically housed the Drennan Motor Co. The standing portion of the building housed the service department and the now demolished front portion housed the sales room.

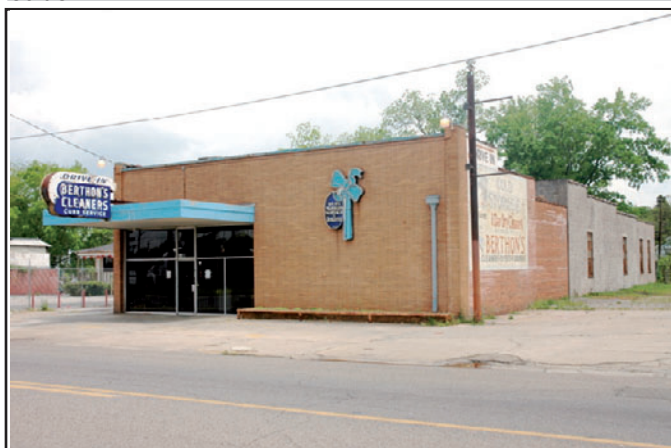
Photo Roll	Neg.	View of:
D128A		Oblique, fac. E
D128B		Oblique, fac. S
D128C		Facade, fac. SE
D128D		Detail

Construction and design details indicate that this building was constructed circa 1925 and that it was remodeled circa 1960; Berthon's Cleaners was established by A.H. Berthon in 1925; Berthon, a French immigrant, began pressing clothes as an ancillary business to his barber shop and the sideline eventually became profitable enough for him to begin his dry cleaning business; this site in Ensley was his the first of the company's five facilities; the northern portion of the building is shown on the 1928 Sanborn map as a "Dry Cleaning and Dyeing" facility; subsequent additions were made to the south circa 1945 and the present building is shown on the 1950 edition.

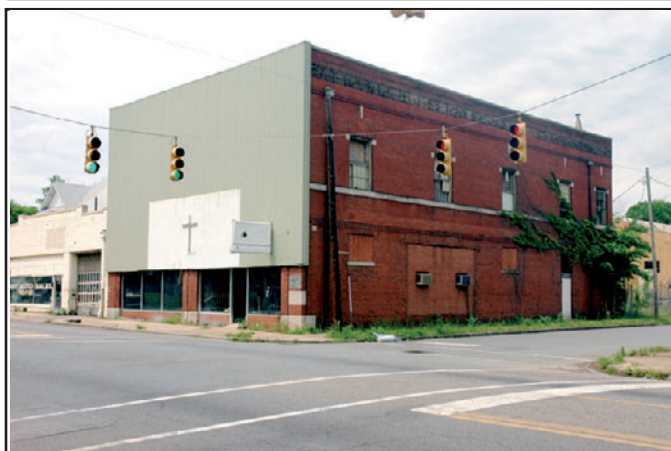
Photo Roll	Neg.	View of:
D130A		Oblique, fac. E
D130B		Oblique, fac. E
D130C	-E	Details

Construction and design details indicate that this building was constructed circa 1925 and that it was remodeled circa 1975; the site is shown as being vacant on the 1911 Sanborn map and the present building is indicated on the 1928 edition as a "Masonic Hall"; by 1950, the building was in used by the Drennan Motor Car Company as an auto repair facility with the Masonic Hall still indicated at the 2nd level.

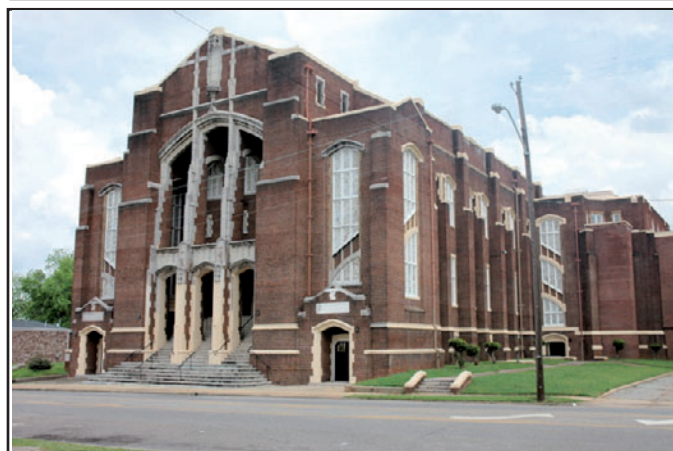
Photo Roll	Neg.	View of:
D131A	-	Oblique, fac. W
D131B	-C	Oblique, fac. S
D131D		Oblique, fac. NE
D131E	-Q	Details

According to its datestone, the Ensley Baptist Church was erected between 1924 and 1929; only the rear portion of the building is shown on the 1928 Sanborn map; the front portion appears to have been added in 1929 and the large ancillary building circa 1965

foundation level with similar windows below, 2x5 bay T wing at rear bays with a 1x1 bay stair tower; SW elevation is similar with ancillary building extending from SW elevation of the rear wing; historic building was built in 2 phases: rear portion between 1924 and 1929 and front portion in 1929, alterations include construction of ancillary building (ca. 1965) and new industrial metal roof (ca. 2005).

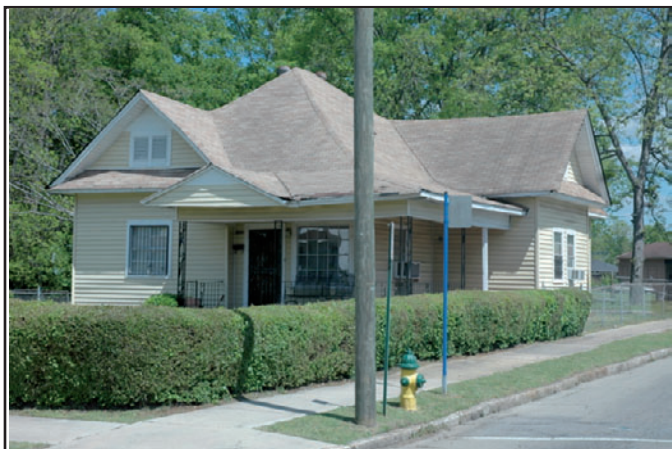
Photo Roll	Neg.	View of:
D165A		Oblique, fac. E
D165B		Facade, fac. SE

Rectangular 1-story frame dwelling with a hipped asphalt shingle roof with decorative cross pedimented gables; faces BNW, 3x2 bays with slightly projecting wings at northern bay of façade and eastern bay of SW elevations, rear extensions; less than full façade gable on hipped porch with decorative metal supports; off-center entrance at façade flanked by a single replacement window and a modern picture window, similar single windows at side elevations; vinyl siding; alterations include the installation of replacement windows (ca. 1965) and vinyl siding (ca. 1990).

Alterations: Date(s): **1975 ca.** Integrity: **good** Condition: **fair**

Construction and design details indicate that this house was constructed circa 1895 and that it was remodeled circa 1965 and 1990. This area of Ensley is not depicted on the 1902 Sanborn map. This house is shown on the 1911 and subsequent editions.

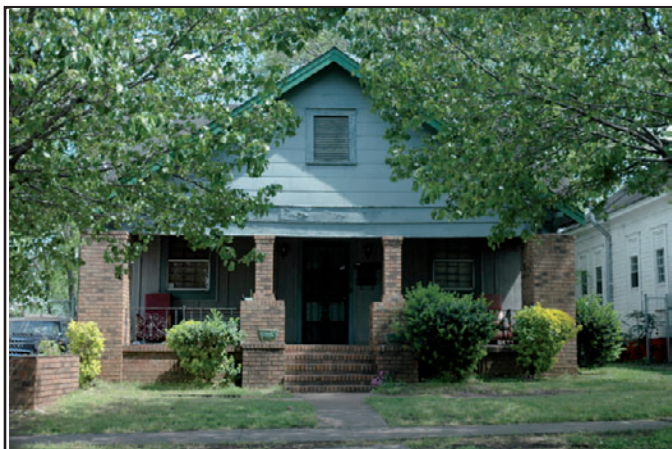
Photo Roll	Neg.	View of:
D168A		Facade, fac. SE
D168BN		Oblique, fac. S

Rectangular 1-story frame gable front form dwelling with a side gable asphalt shingle roof; faces NW, 3x2 bay core with secondary rear wing; full façade gable porch with outer brick pillars and inner brick supports on brick pedestals; central entrance at façade flanked by single replacement aluminum horizontal 2/2 windows; similar windows at side elevations; replacement asbestos shingle siding (ca. 1960), thin boxed cornice with returns and frieze boards.

Alterations: Date(s): 1960 ca. Integrity: good Condition: good

replacement asbestos shingle siding

Construction and design details indicate that this house was constructed circa 1925. A house with a similar footprint is shown on the 1911 Sanborn map but appears to be a different house. This house appears on both the 1928 and 1950 editions.

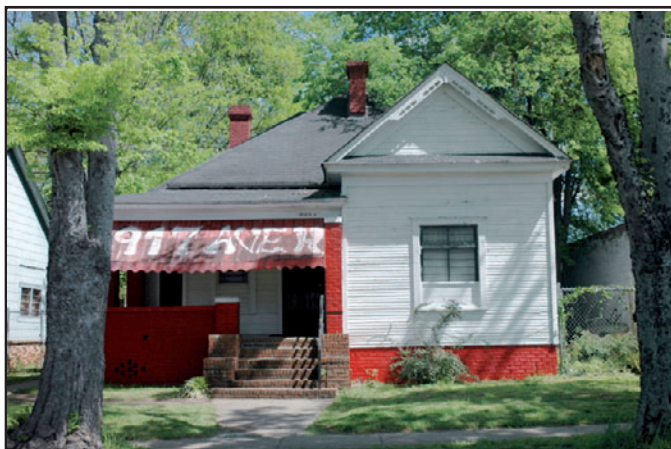
Photo Roll	Neg.	View of:
D169A		Facade, fac. SE
D169B		Oblique, fac. S
D169C		Oblique, fac. E

Alterations: Date(s): **ca. 1925, ca. 1965** Integrity: **good** Condition: **good**

rear extension and replacement porch elements (ca. 1925), modern aluminum awning at porch and replacement windows

Construction and design details indicate that this house was constructed circa 1895 and that it was remodeled circa 1925 and circa 1965. This area of the city was not depicted on the 1902 Sanborn map. This house is shown on the 1911 map without the present rear extension. This house appears in its present configuration on both the 1928 and 1950 editions.

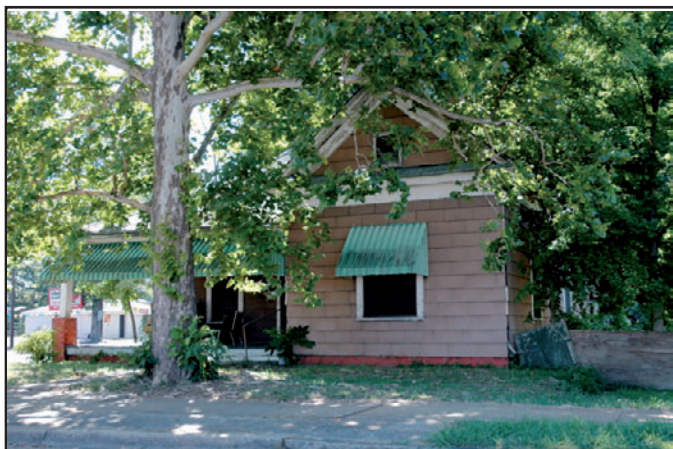
Photo Roll Neg. View of:
D170A _____ Oblique, fac. E
D170B _____ Oblique, fac. S

Alterations: Date(s): **ca. 1925, ca. 1960** Integrity: **fair** Condition: **good**

replacement porch elements (ca. 1925), replacement asbestos shingle siding (ca. 1960)

Construction and design details indicate that this house was constructed circa 1895 and that it was remodeled circa 1925 and circa 1960. This area of the city was not depicted on the 1902 Sanborn map. This house appears in its present configuration on the 1911, 1928 and 1950 editions.

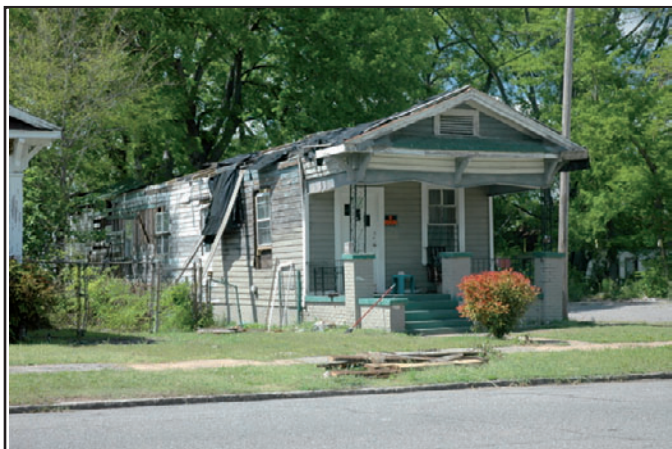
Rectangular 1-story frame gable front shotgun form dwelling with a front-facing pedimented gable asphalt shingle roof; faces SE, 2x4 bay core; full façade gable porch with decorative metal supports on brick pedestals; entrance south bay of façade flanked by a single 4/4 double hung sash window, similar windows and replacement windows at side elevations; wood novelty siding; alterations include rear replacement porch elements and some replacement windows (ca. 1960).

Alterations: Date(s): **ca. 1960** Integrity: **good** Condition: **deteriorated**

replacement porch elements and some replacement windows

Construction and design details indicate that this house was constructed circa 1925 and that it was remodeled circa 1960. This area of the city was not depicted on the 1902 Sanborn map. The site is shown as being vacant on the 1911 map and this house appears in its present configuration on the 1928 and 1950 editions.

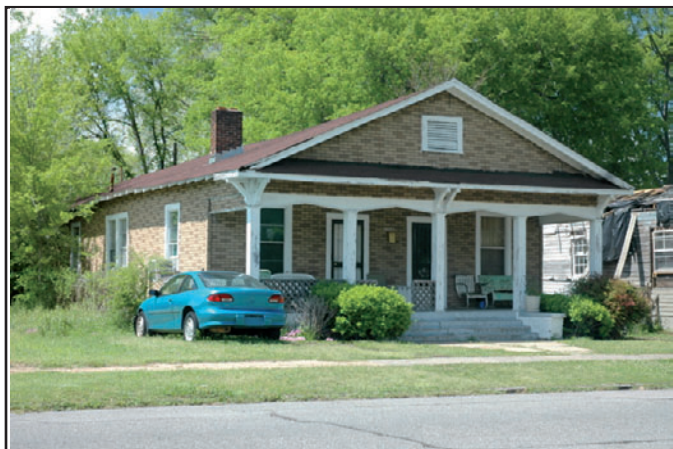
Photo Roll Neg. View of:
D173A _____ Oblique, fac. N

Rectangular 1-story frame gable front form dwelling with a front-facing pedimented gable asphalt shingle roof with exposed rafter ends, 2 interior brick chimneys; faces SE, 4x3 bay core; full façade recessed porch with wood posts supporting shaped arches; 2 central entrances flanked by single replacement horizontal 2/2 double hung sash windows, similar windows at side elevations; replacement asphalt shingle siding; alterations include replacement windows and asphalt shingle siding (ca. 1960).

Alterations: Date(s): **1960 ca.** Integrity: **fair** Condition: **fair**

replacement windows and asphalt shingle siding

Construction and design details indicate that this house was constructed circa 1925 and that it was remodeled circa 1960. This area of the city was not depicted on the 1902 Sanborn map. The site is shown as being vacant on the 1911 map and this house appears in its present configuration on the 1928 and 1950 editions.

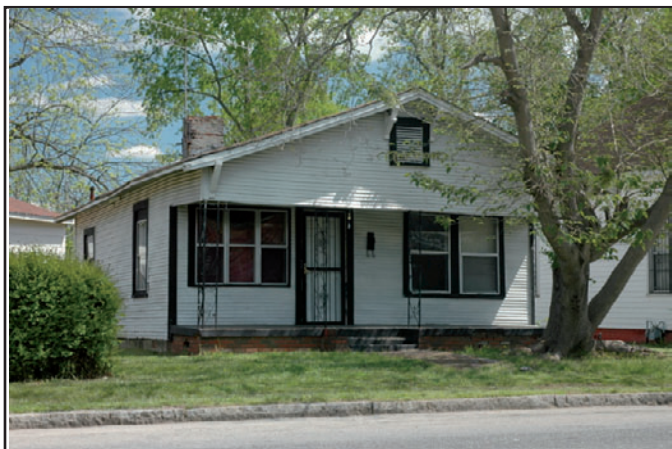
Photo Roll Neg. View of:
D175A **Oblique, fac. S**

Rectangular 1-story frame gable front form dwelling with a front-facing gable asphalt shingle roof with angle bracketed eaves, 1 interior brick chimney; faces SE, 3x2 bay core; full facade recessed porch with replacement metal supports; off-center entrance at facade flanked by a double replacement horizontal 2/2 window and a triple aluminum replacement window, similar single aluminum replacement windows at side elevations; wood novelty siding; alterations include replacement windows (ca. 1955 and ca. 1970) and porch supports (ca. 1970).

Alterations: Date(s): **ca. 1955; ca. 1970** Integrity: **good** Condition: **good**

replacement windows (ca. 1955 and ca. 1970) and porch supports (ca. 1970).

Construction and design details indicate that this house was constructed circa 1925 and that it was remodeled circa 1955 and circa 1970. This area of the city was not depicted on the 1902 Sanborn map. The site is shown as being vacant on the 1911 map and this house appears as a duplex on the 1928 and 1950 editions.

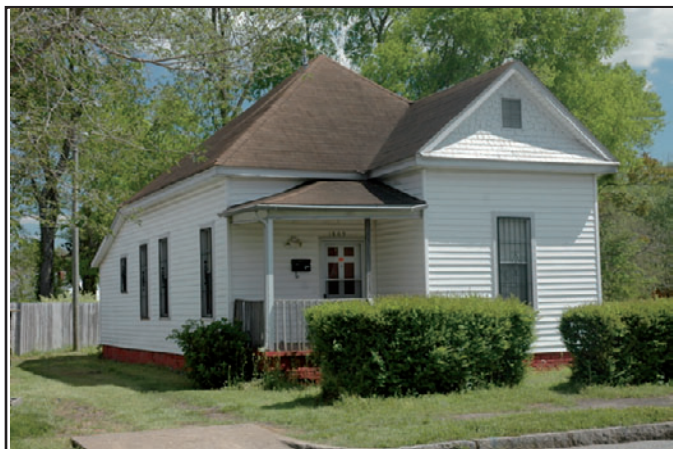
Photo Roll Neg. View of:
D176A **Oblique, fac. S**

Rectangular 1-story frame pyramidal form dwelling with a hipped asphalt shingle roof with a secondary pedimented cross gable at the S bay of its facade; faces NW, 2x3 bay core with slightly projecting S bay of facade, rear shed extension; less than full facade hipped porch with wood post and modern railing; entrance at N bay of facade flanked by a single horizontal 2/2 replacement window, similar windows at side elevations; replacement vinyl siding, historic wood shingles at gable end; alterations include replacement windows (ca. 1955) and replacement vinyl siding (ca. 1995).

Alterations: Date(s): **ca. 1955, ca. 1995** Integrity: **fair** Condition: **good**
replacement windows (ca. 1955) and replacement vinyl siding (ca. 1995).

Construction and design details indicate that this house was constructed circa 1895 and that it was remodeled circa 1955 and circa 1995. This area of the city was not depicted on the 1902 Sanborn map. This house is shown on the 1911, 1928 and 1950 editions.
