ENSLEY

Historic Building Survey

And National Register Nomination - 2008

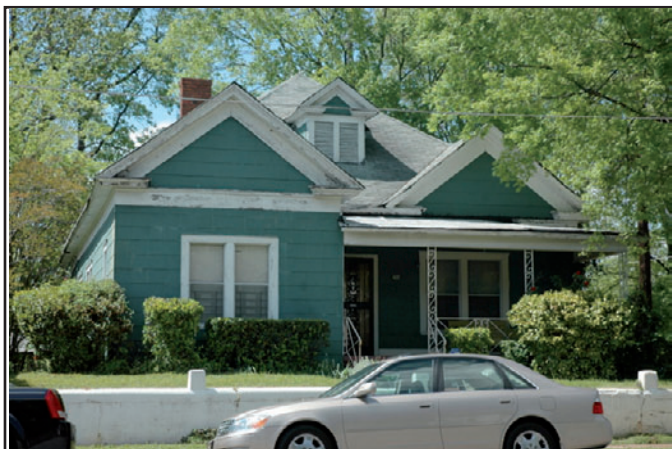
Photo Roll Neg. View of:
D178A **Oblique, fac. N**

Rectangular 1-story frame pyramidal form dwelling with a hipped asphalt shingle roof with secondary cross gables at outer bays of its front slope, central decorative dormer with attic louvers, 1 interior brick chimney; faces SE, 3x2 bay core with slightly projecting S bay of façade, rear extension; less than full façade hipped porch with replacement decorative metal supports and railing; central entrance at façade flanked by a double 1/1 double hung sash windows, similar single windows at side elevations; replacement asbestos shingle siding, historic thin boxed cornice with gable returns and frieze board; alterations include replacement asbestos shingle siding and porch supports (ca. 1960).

Alterations: Date(s): **ca. 1960** Integrity: **good** Condition: **good**

replacement asbestos shingle siding and porch supports

Construction and design details indicate that this house was constructed circa 1895 and that it was remodeled circa 1960. This area of the city was not depicted on the 1902 Sanborn map. This house is shown on the 1911, 1928 and 1950 editions.

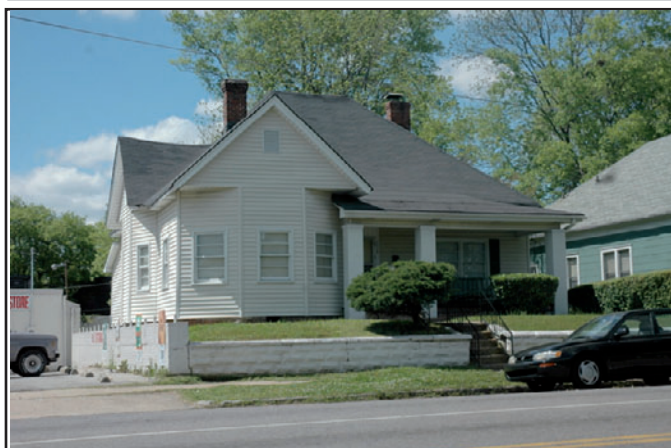
Rectangular 1-story frame pyramidal form dwelling with a hipped asphalt shingle roof with a secondary cross gable at the southern bay of its front slope and the center bay of its SW elevation, 2 interior brick chimneys; faces SE, 3x2 bay core with slightly projecting cutaway bay at the south bay of its façade and the center bay of its SW elevation; less than full façade hipped porch with replacement brick pillars; central entrance at façade flanked to the N by a double replacement horizontal 2/2 window and to the S by 3 single similar windows at the cutaway bay, similar windows at side elevations; replacement vinyl siding; alterations include replacement windows (ca. 1955) and vinyl siding (ca. 1995).

Alterations: Date(s): **ca. 1955, ca. 1995** Integrity: **fair** Condition: **good**

include replacement windows (ca. 1955) and vinyl siding (ca. 1995).

Construction and design details indicate that this house was constructed circa 1895 and that it was remodeled circa 1955 and circa 1995. This area of the city was not depicted on the 1902 Sanborn map. This house is shown on the 1911, 1928 and 1950 editions.

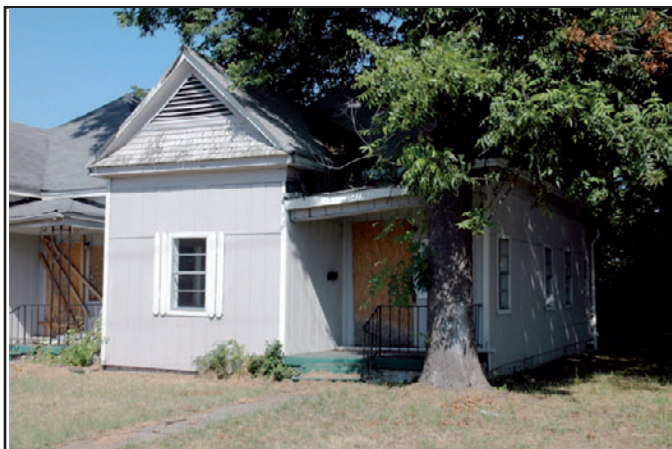
Photo Roll Neg. View of:
D180A **Oblique, fac. N**

Rectangular 1-story frame pyramidal form dwelling with a hipped asphalt shingle roof with a secondary pedimented cross gable at the southern bay of its front slope; faces SE, 3x4 bay core with slightly projecting bay at the south bay of its façade; less than full façade hipped porch with replacement metal support and railing; entrance at N bay if façade flanked by a single replacement aluminum horizontal 2/2 window, similar windows at side elevations; replacement plywood siding; alterations include replacement windows (ca. 1965) and vinyl siding (ca. 1985).

Alterations: Date(s): **ca. 1965, ca. 1985** Integrity: **fair** Condition: **fair**

replacement windows (ca. 1965) and vinyl siding (ca. 1985).

Construction and design details indicate that this house was constructed circa 1895 and that it was remodeled circa 1965 and circa 1985. This area of the city was not depicted on the 1902 Sanborn map. This house is shown on the 1911, 1928 and 1950 editions.
