Brierfield Coal and Iron Company Superintendent's House

Brierfield, Bibb County, Alabama

Historic Structures Report

September 2009

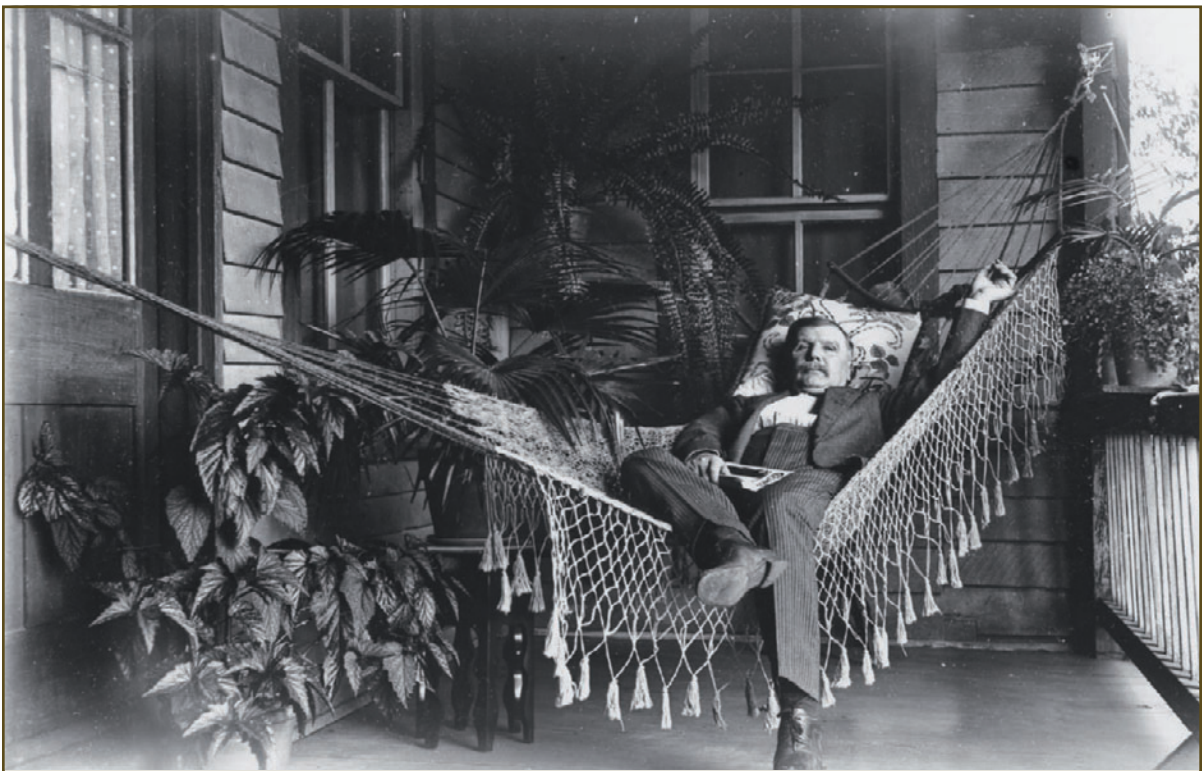
*Historic View, circa 1900-1910, Photo courtesy of Eugene Jones, Jr.
Note the historic 4/4 windows, 4-light over 2 panel door, porch railing, and evidence of a decorative paint scheme.*

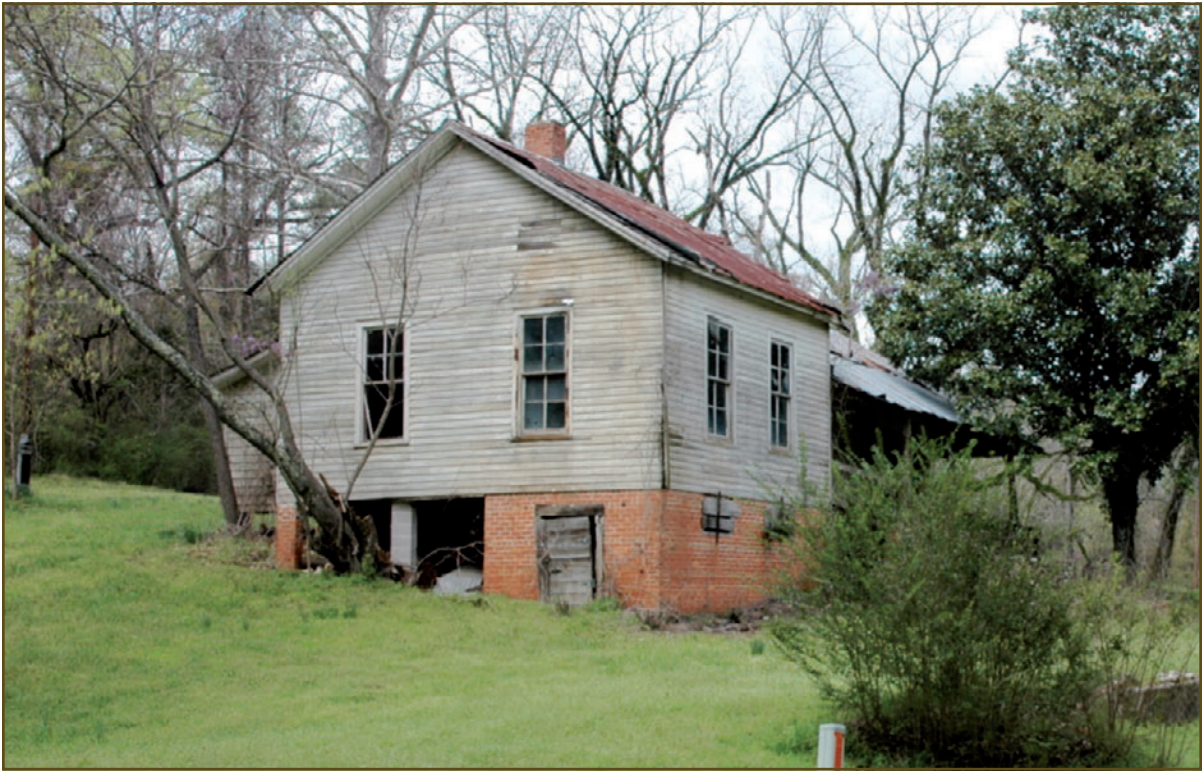
Photo #1. House, View #1, East Facade (Right) and South (Left) Elevation, Camera Facing Northwest

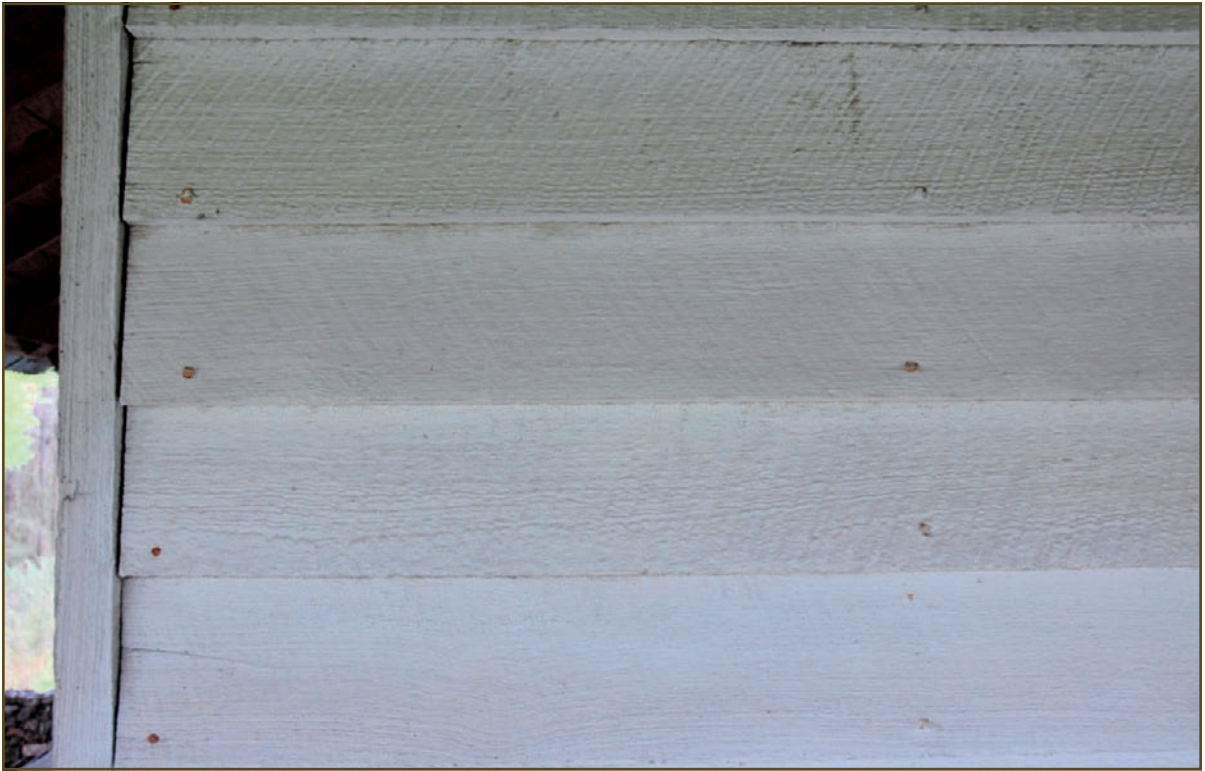
The exterior of the house is clad with wood weatherboard. Siding at the core is attached with cut iron nails while siding at the addition is attached with wire nails. Siding is smooth sawn except at the north elevation where the siding appears to be a modern replacement.

Photo #19 House, View #19, North Elevation, Detail of Siding, Camera Facing South

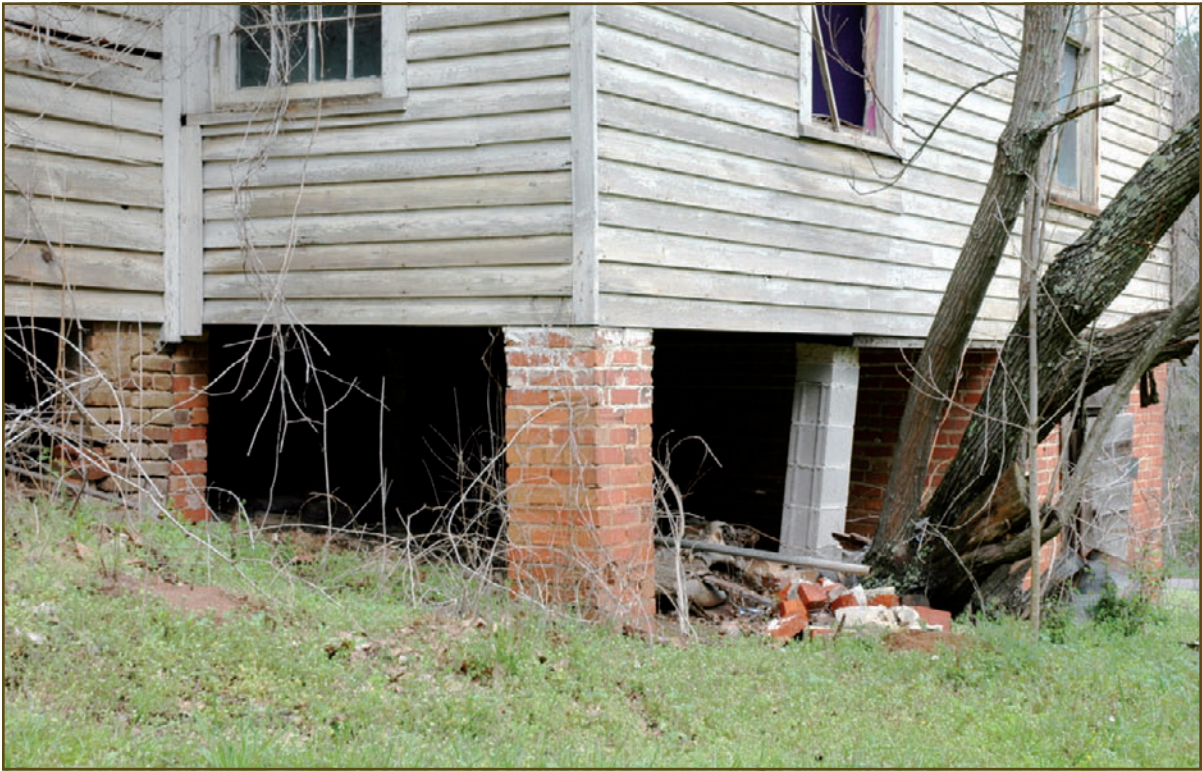
The house is supported by brick piers with a brick cellar below the east side of the addition. The cellar has a single entrance with a horizontal board door at its south elevation. Two short windows placed high on the east elevation of the cellar are now covered with wood. The interior of the cellar was not accessible but could be photographed and appears to be whitewashed. The flooring could not be determined. Floor framing consists of circular sawn floor joists and beams. Diagonal cross bracing is found between the joists at the addition only.

Photo #27 House, View #27, Detail of Brick Piers, Southwest Corner, Camera Facing Northeast

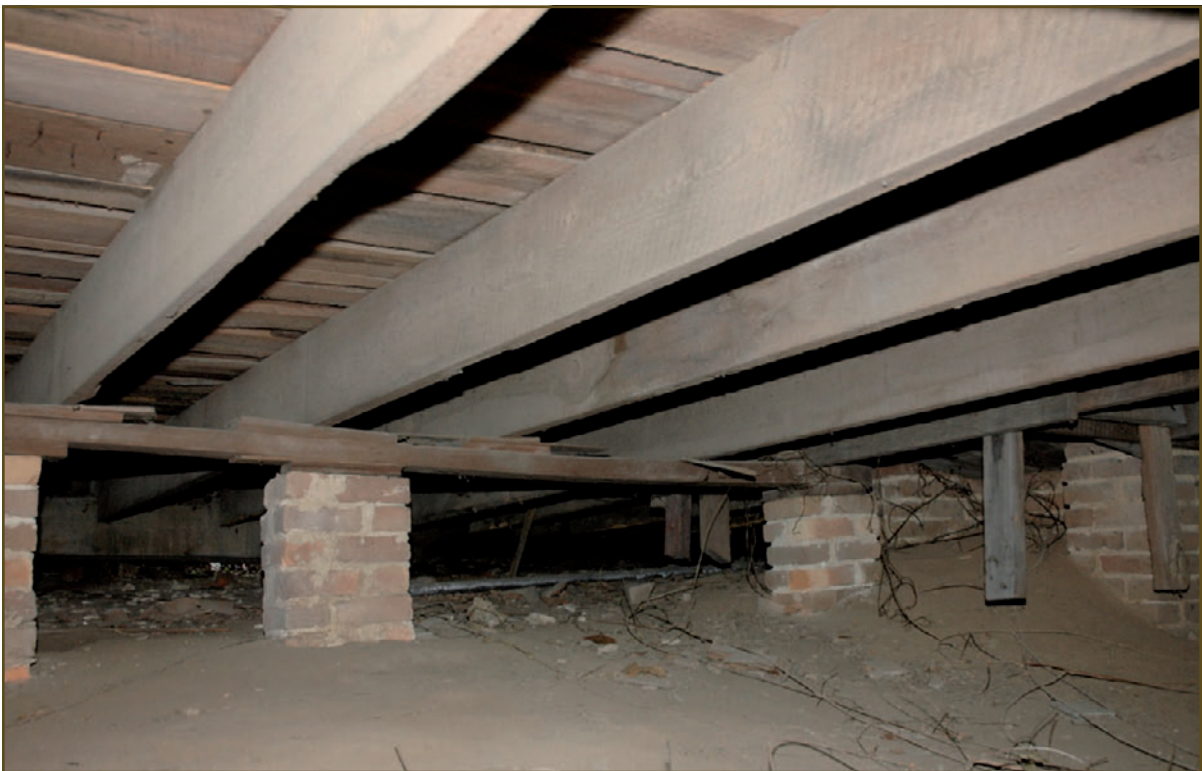
Photo #28 House, View #28, Detail of Floor Framing at Core, Camera Facing Northwest

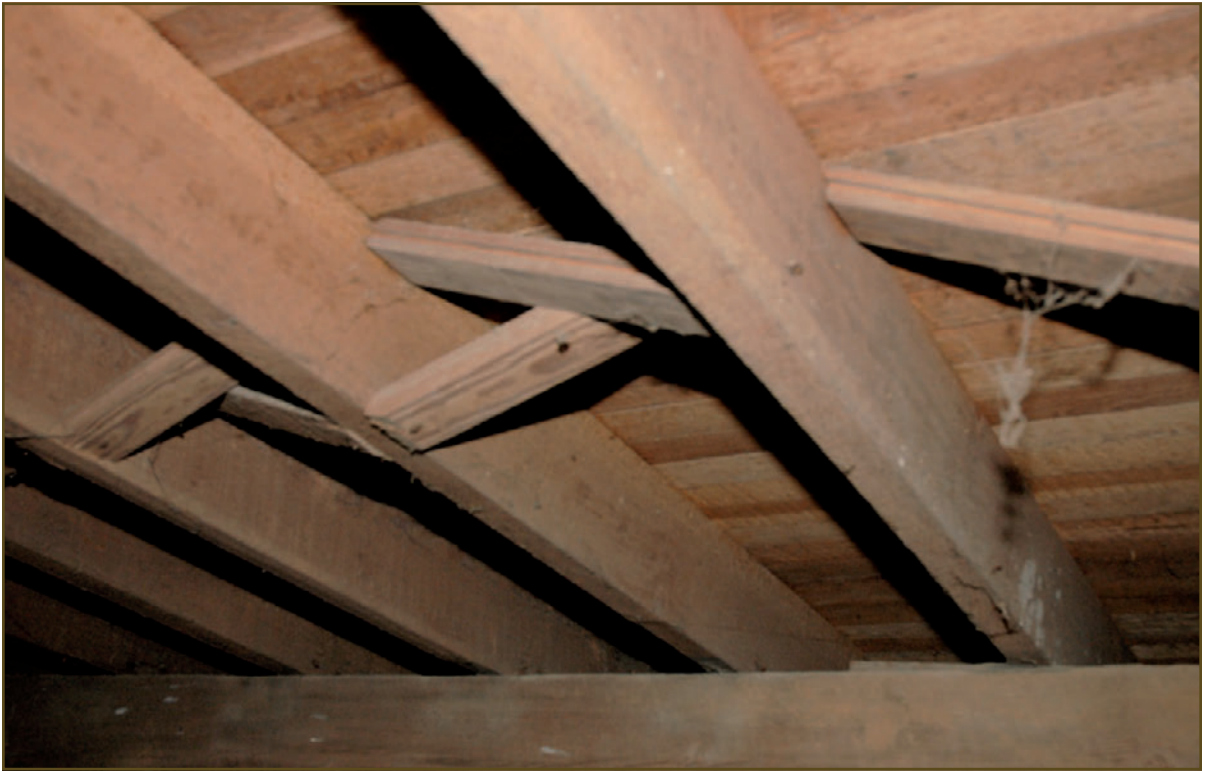
Photo #29 House, View #29, Detail of Floor Framing at Addition, Camera Facing Southwest

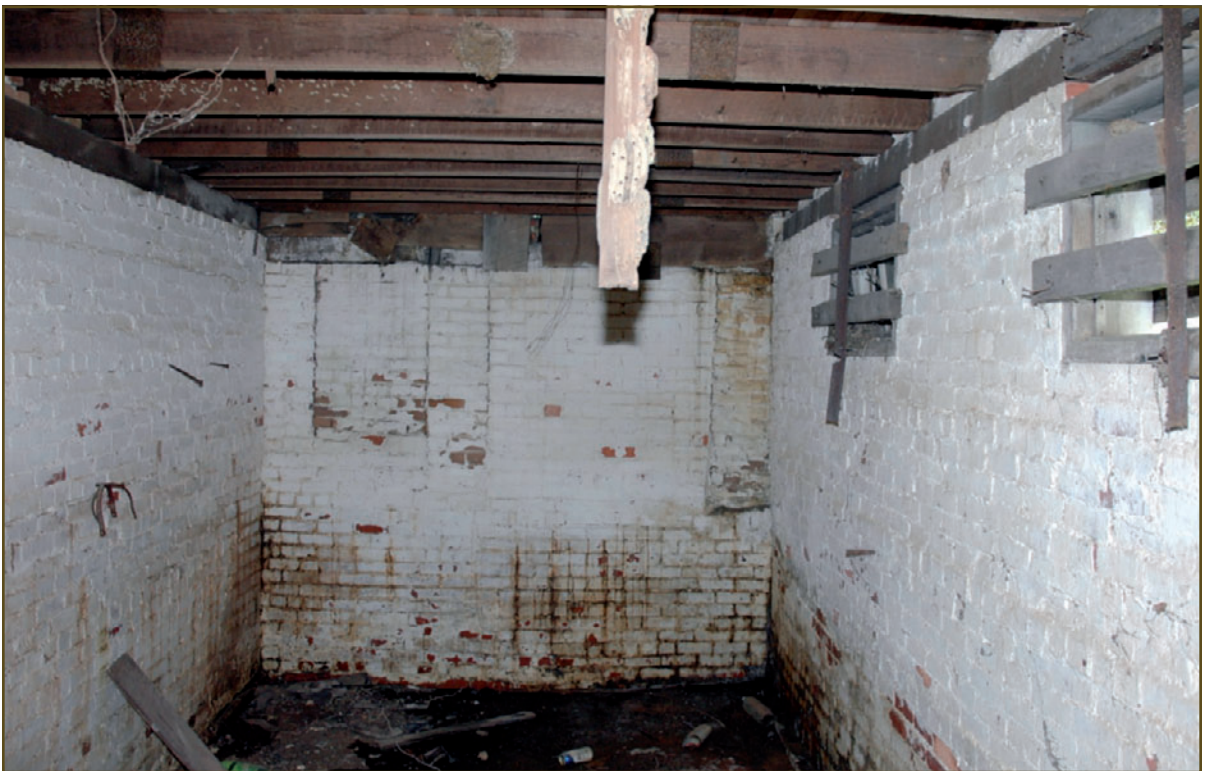
Photo #30. House, View #30, View of Basement, Camera Facing North

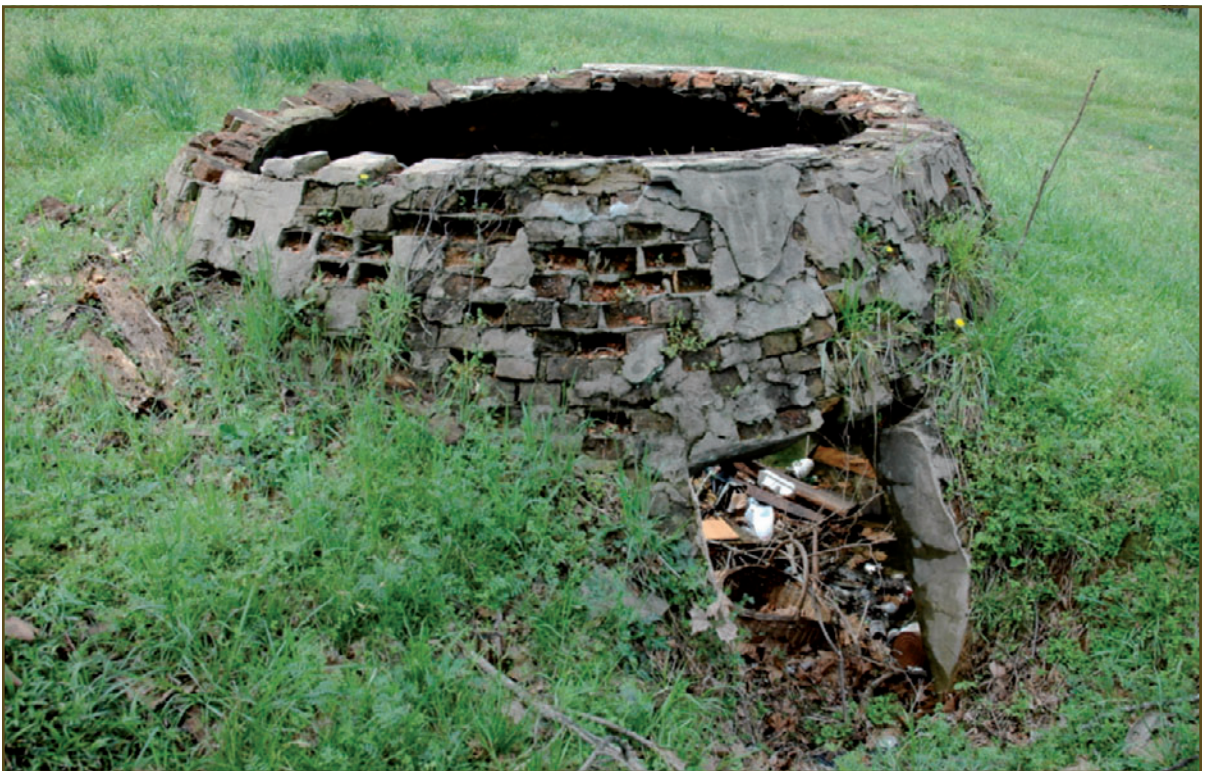
Photo #55. Cellar, View #1, Camera Facing Northwest

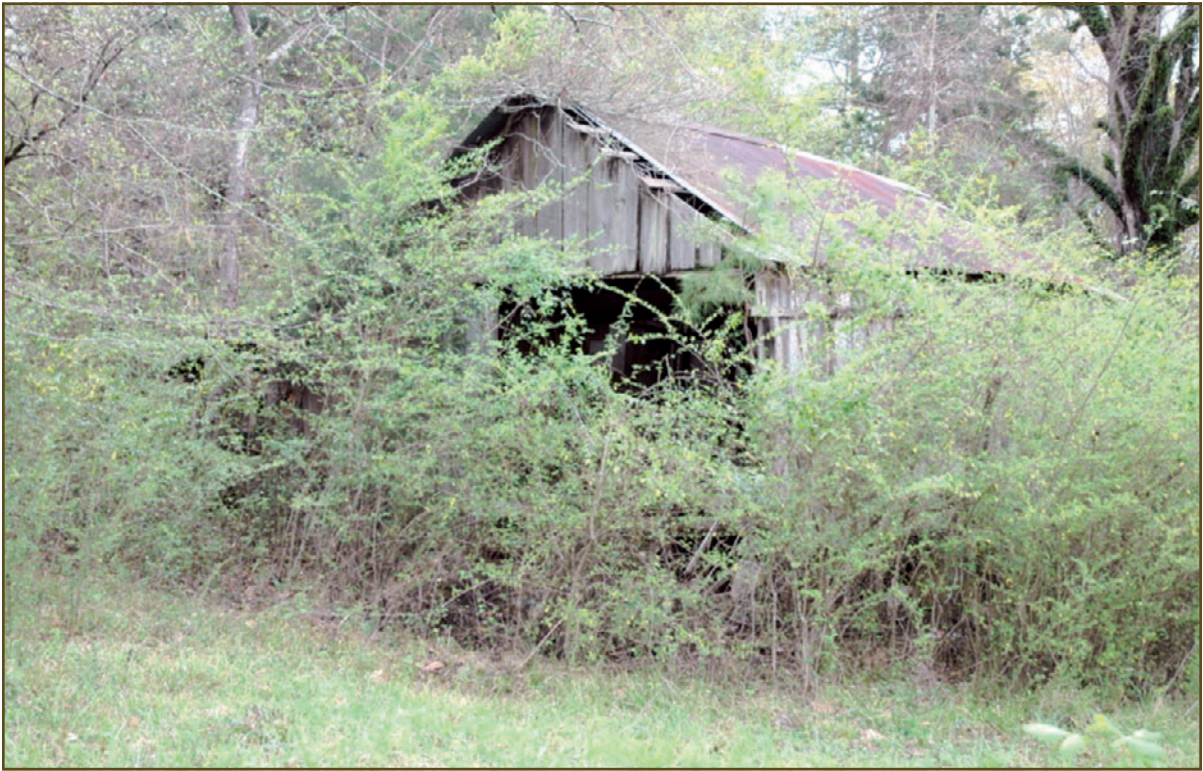
Rectangular frame shed measuring 16'9" by 20'1" with a gable corrugated metal roof. The building has a small shed extension to the west, is clad with vertical board siding, and is in near ruinous condition.

Photo #58. Shed, View #1, South (Left) and East (Right) Elevations, Camera Facing Northwest

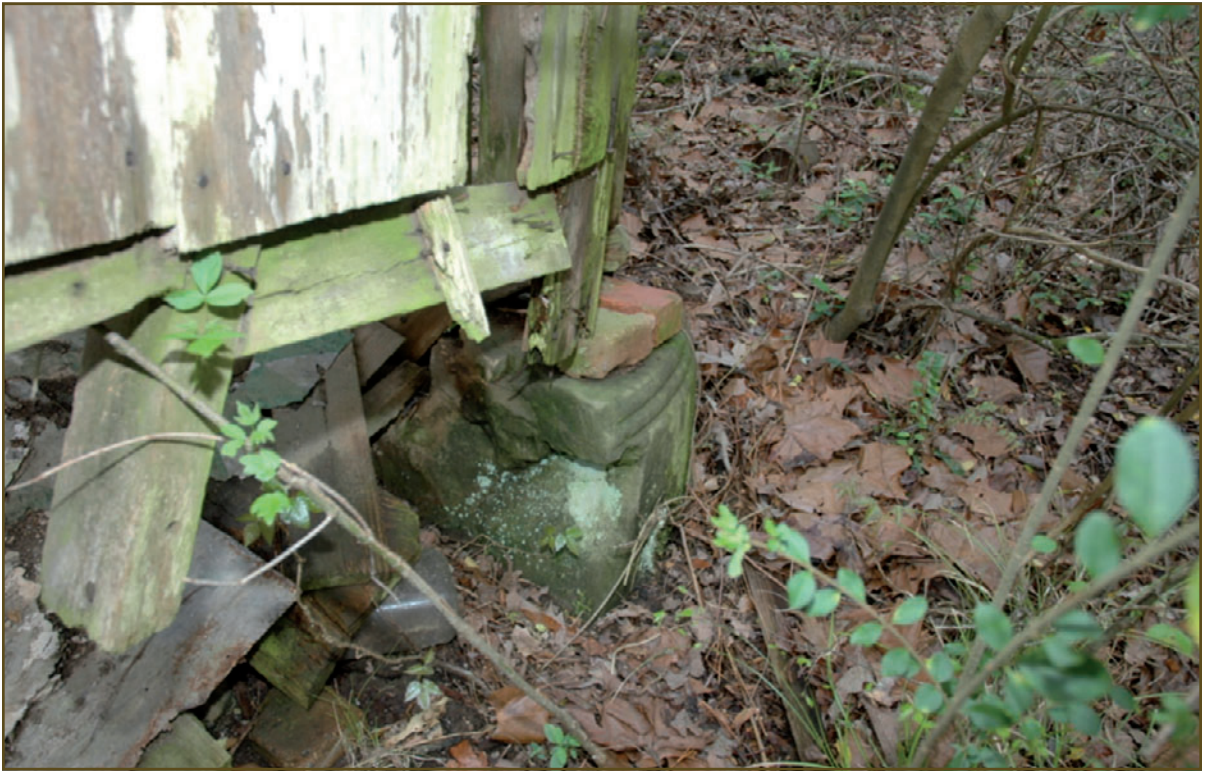
Photo #64. Shed, View #7, Detail of Stone Pier (Possible remnant of an old mill stone?)
